# Access Compliance Report
# Public Rights-of-Way
# (Curb Ramps)

| Intersection ID: 21746 | Main Street: INTERNATIONAL_DR | Cross Street: PROVIDENCE_RD | Location: | NE |
| ADA ID: 155DC0731BD6 | Ramp Type: BlendTrans1 | Initial Pass/Fail: Fail | Overall Compliance: No | Severity Score: 25 |

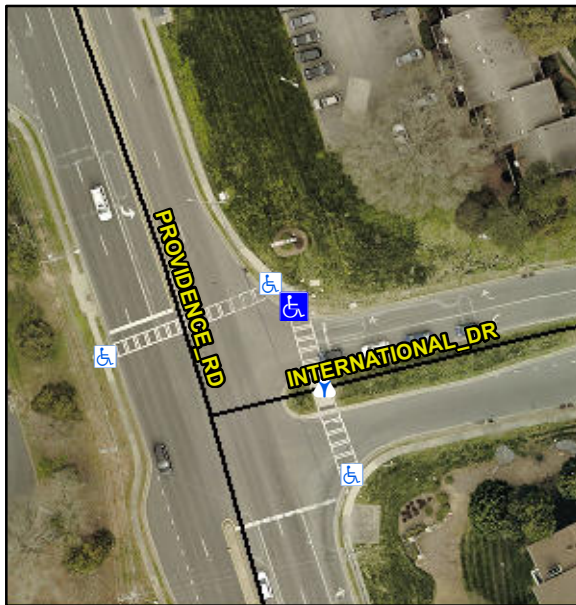
**Not Found, R304.5.3**

| Compliance | Description | Data | Compliance | Description | Data |
|---|---|---|---|---|---|
| Yes | Ramp Width (in) | 49.0 | No | BlendTrans XSlope (%) | 14.2 |
| | | | No | Curb Slope (%) | 6.4 |

**Remove & Replace Curb Ramp With Two New Directional Ramps or Equivalent.**
