Access Compliance Report
Public Rights-of-Way
(Curb Ramps)

Intersection ID: 2609 | **Main Street:** ANZACK_LN | **Cross Street:** HARTFIELD_DOWNS_DR | **Location:** SE

ADA ID: 15C7381CD3BF | **Ramp Type:** BlendTrans1 | **Initial Pass/Fail:** Fail | **Overall Compliance:** No | **Severity Score:** 10

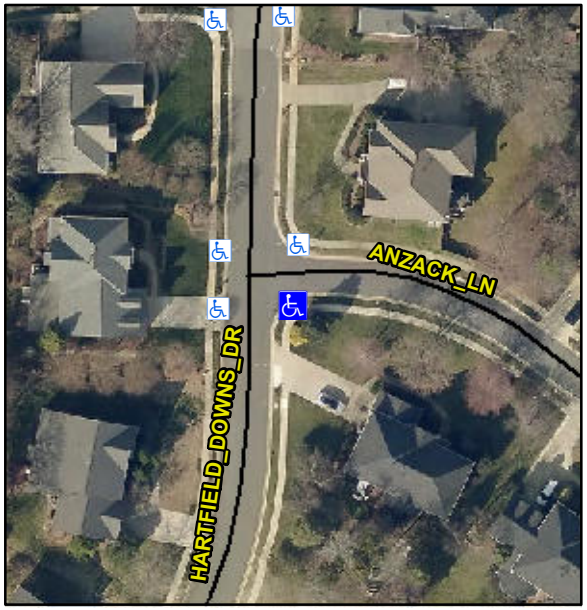
R304.5.1, R304.5.3

Compliance	Description	Data	Compliance	Description	Data
N/A	Ramp Length (in)	47.0	Yes	BlendTrans Slope (%)	2.5
No	Ramp Width (in)	45.5	No	BlendTrans XSlope (%)	3.8
N/A	Flare Type LT	N/A	N/A	Flare Type RT	N/A
N/A	Flare Slope LT (%)	N/A	N/A	Flare Slope RT (%)	N/A
N/A	Flare Traversable LT?	N/A	N/A	Flare Traversable RT?	N/A
N/A	Landing Length (in)	N/A	N/A	DWS Provided?	N/A
N/A	Landing Width (in)	N/A	N/A	DWS Contrast?	N/A
N/A	Landing Slope (%)	N/A	N/A	DWS Length (in)	N/A
N/A	Landing X Slope (%)	N/A	N/A	DWS Full Width?	N/A
N/A	Landing Curb? (Y/N)	N/A	N/A	DWS Offset (in)	N/A
N/A	Shared Landing?	N/A			
N/A	Gutter Ponding?	N/A	N/A	Gutter Slope (%)	N/A
N/A	Gutter Lip Ht (in)	N/A	N/A	Gutter X Slope (%)	N/A
N/A	Painted X Walk1?	No	N/A	Painted X Walk2?	No
	X Walk 1 Direction	To N		X Walk 2 Direction	To W
	X Walk 1 Width (in)	N/A		X Walk 2 Width (in)	N/A
	X Walk 1 Slope (%)	2.6		X Walk 2 Slope (%)	4.2
	X Walk 1 X Slope (%)	3.3		X Walk 2 X Slope (%)	7.4

Remove & Replace Curb Ramp With Two New Directional Ramps or Equivalent.
