# Access Compliance Report
# Public Rights-of-Way
# (Curb Ramps)

| **Intersection ID:** 23581 | **Main Street:** BRANDON_FOREST_DR | **Cross Street:** DRYDEN_LN | **Location:** | E |
| **ADA ID:** 1610DCCD5A11 | **Ramp Type:** PerpDiag | **Initial Pass/Fail:** Fail | **Overall Compliance:** No | **Severity Score:** 13.75 |

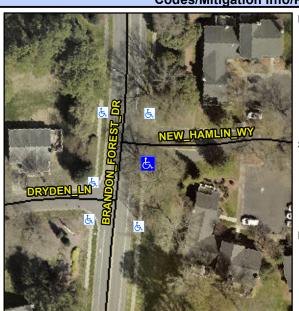
**Not Found, R304.2.2, R304.5.3**

| Compliance | Description | Data | Compliance | Description | Data |
|---|---|---|---|---|---|
| N/A | Ramp Length (in) | 32.0 | No | Ramp Slope (%) | 11.3 |
| Yes | Ramp Width (in) | 48.0 | No | Ramp XSlope (%) | 3.9 |

**Remove & Replace Curb Ramp With Two New Directional Ramps or Equivalent.**
