Access Compliance Report
Public Rights-of-Way
(Curb Ramps)

Intersection ID: 2977	Main Street: ELDERSLIE_DR	Cross Street: HARBURN_FOREST_DR	Location:	NW
ADA ID: 173C8F548A93	Ramp Type: PerpDiag	Initial Pass/Fail: Fail	Overall Compliance: No	Severity Score: 50

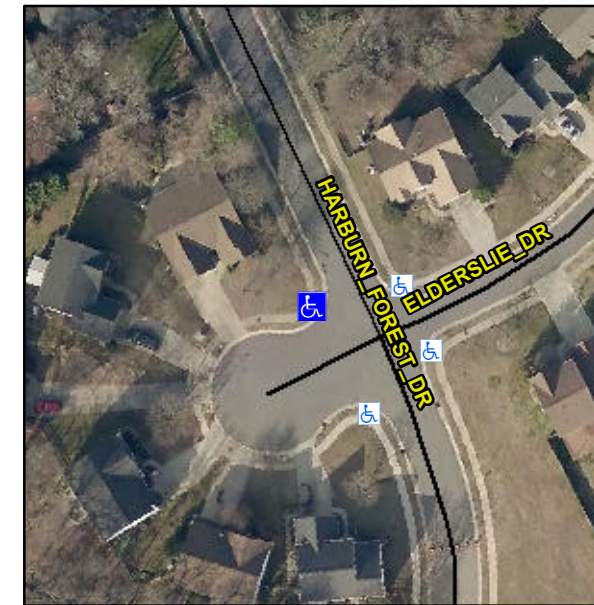
Not Found, R304.2.2, R304.5.3

Compliance	Description	Data	Compliance	Description	Data
N/A	Ramp Length (in)	48.0	No	Ramp Slope (%)	13.4
Yes	Ramp Width (in)	64.0	No	Ramp XSlope (%)	9.8
N/A	Flare Type LT	N/A	N/A	Flare Type RT	N/A
N/A	Flare Slope LT (%)	N/A	N/A	Flare Slope RT (%)	N/A
N/A	Flare Traversable LT?	N/A	N/A	Flare Traversable RT?	N/A
N/A	Landing Length (in)	N/A	N/A	DWS Provided?	N/A
N/A	Landing Width (in)	N/A	N/A	DWS Contrast?	N/A
N/A	Landing Slope (%)	N/A	N/A	DWS Length (in)	N/A
N/A	Landing X Slope (%)	N/A	N/A	DWS Full Width?	N/A
N/A	Landing Curb? (Y/N)	N/A	N/A	DWS Offset (in)	N/A
N/A	Shared Landing?	N/A			
N/A	Gutter Ponding?	N/A	N/A	Gutter Slope (%)	N/A
N/A	Gutter Lip Ht (in)	N/A	N/A	Gutter X Slope (%)	N/A
N/A	Painted X Walk1?	No	N/A	Painted X Walk2?	No
	X Walk 1 Direction	To S		X Walk 2 Direction	To E
N/A	X Walk 1 Width (in)	N/A	N/A	X Walk 2 Width (in)	N/A
	X Walk 1 Slope (%)	5.0		X Walk 2 Slope (%)	0.9
	X Walk 1 X Slope (%)	5.3		X Walk 2 X Slope (%)	5.3

Remove & Replace Curb Ramp With Two New Directional Ramps or Equivalent.
