Access Compliance Report
Public Rights-of-Way
(Curb Ramps)

Intersection ID: 22832	Main Street: IMPERIAL_OAK_LN	Cross Street: OAKBRIAR_LN	Location:	S
ADA ID: 177629239281	Ramp Type: Perp	Initial Pass/Fail: Fail	Overall Compliance: No	Severity Score: 25

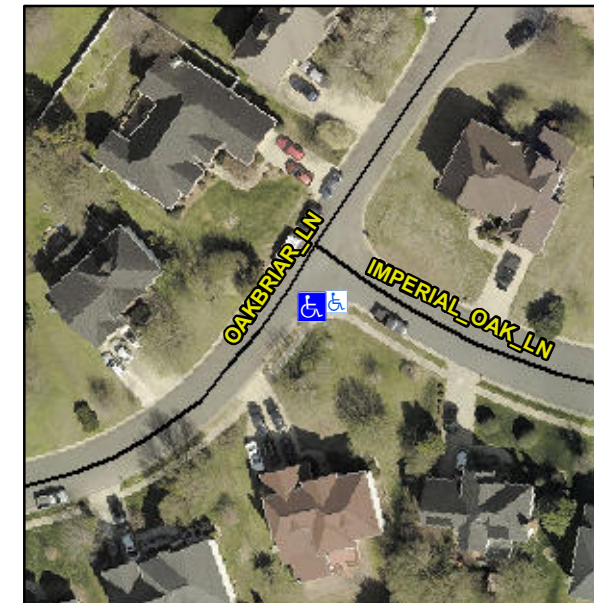
Not Found, R304.2.2

Compliance	Description	Data	Compliance	Description	Data
N/A	Ramp Length (in)	45.0	No	Ramp Slope (%)	13.9
Yes	Ramp Width (in)	48.0	Yes	Ramp XSlope (%)	1.6
N/A	Flare Type LT	N/A	N/A	Flare Type RT	N/A
N/A	Flare Slope LT (%)	N/A	N/A	Flare Slope RT (%)	N/A
N/A	Flare Traversable LT?	N/A	N/A	Flare Traversable RT?	N/A
N/A	Landing Length (in)	N/A	N/A	DWS Provided?	N/A
N/A	Landing Width (in)	N/A	N/A	DWS Contrast?	N/A
N/A	Landing Slope (%)	N/A	N/A	DWS Length (in)	N/A
N/A	Landing X Slope (%)	N/A	N/A	DWS Full Width?	N/A
N/A	Landing Curb? (Y/N)	N/A	N/A	DWS Offset (in)	N/A
N/A	Shared Landing?	N/A			
N/A	Gutter Ponding?	N/A	N/A	Gutter Slope (%)	N/A
N/A	Gutter Lip Ht (in)	N/A	N/A	Gutter X Slope (%)	N/A
N/A	Painted X Walk1?	No	N/A	Painted X Walk2?	N/A
	X Walk 1 Direction	To NW		X Walk 2 Direction	N/A
N/A	X Walk 1 Width (in)	N/A	N/A	X Walk 2 Width (in)	N/A
	X Walk 1 Slope (%)	5.5		X Walk 2 Slope (%)	N/A
	X Walk 1 X Slope (%)	1.7		X Walk 2 X Slope (%)	N/A

Remove & Replace Entire Ramp.
