# Access Compliance Report
Public Rights-of-Way
(Curb Ramps)

Intersection ID: 1002389	Main Street: DAVID_TAYLOR_DR	Cross Street: N/A	Location:	W
ADA ID: 17BF4FC857E1	Ramp Type: Perp	Initial Pass/Fail: Fail	Overall Compliance: No	Severity Score: 33.75

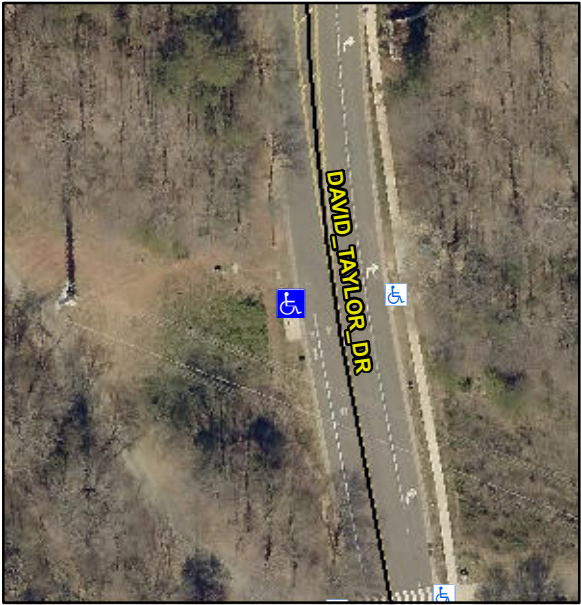
R304.5.1, R304.2.2

Compliance	Description	Data	Compliance	Description	Data
N/A	Ramp Length (in)	96.0	No	Ramp Slope (%)	20.0
No	Ramp Width (in)	47.0	Yes	Ramp XSlope (%)	0.9
N/A	Flare Type LT	N/A	N/A	Flare Type RT	N/A
N/A	Flare Slope LT (%)	N/A	N/A	Flare Slope RT (%)	N/A
N/A	Flare Traversable LT?	N/A	N/A	Flare Traversable RT?	N/A
N/A	Landing Length (in)	N/A	N/A	DWS Provided?	N/A
N/A	Landing Width (in)	N/A	N/A	DWS Contrast?	N/A
N/A	Landing Slope (%)	N/A	N/A	DWS Length (in)	N/A
N/A	Landing X Slope (%)	N/A	N/A	DWS Full Width?	N/A
N/A	Landing Curb? (Y/N)	N/A	N/A	DWS Offset (in)	N/A
N/A	Shared Landing?	N/A			
N/A	Gutter Ponding?	N/A	N/A	Gutter Slope (%)	N/A
N/A	Gutter Lip Ht (in)	N/A	N/A	Gutter X Slope (%)	N/A
N/A	Painted X Walk1?	No	N/A	Painted X Walk2?	N/A
	X Walk 1 Direction	To E		X Walk 2 Direction	N/A
N/A	X Walk 1 Width (in)	N/A	N/A	X Walk 2 Width (in)	N/A
	X Walk 1 Slope (%)	2.9		X Walk 2 Slope (%)	N/A
	X Walk 1 X Slope (%)	1.3		X Walk 2 X Slope (%)	N/A

Remove & Replace Entire Ramp.
