Intersection ID: 11894	Main Street: N_BREVARD_ST	Cross Street: E_12TH_ST	Location: E
ADA ID: 17CE1362B6F1	Ramp Type: Perp	Initial Pass/Fail: Pass	Overall Compliance: No	Severity Score: 0.25

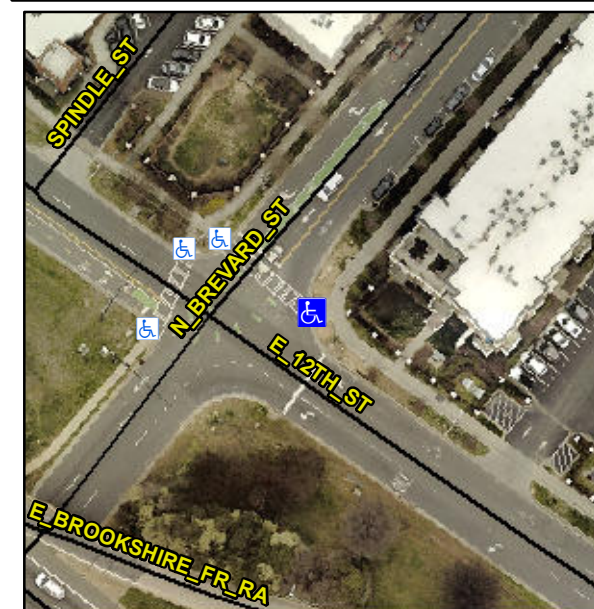
Not Found, R304.5.3, R305.2

Compliance	Description	Data	Compliance	Description	Data
N/A	Ramp Length (in)	115.0	Yes	Ramp Slope (%)	7.6
Yes	Ramp Width (in)	48.0	No	Ramp XSlope (%)	4.3
N/A	Flare Type LT	Sloped	N/A	Flare Type RT	N/A
N/A	Flare Slope LT (%)	3.3	Yes	Flare Slope RT (%)	10.0
N/A	Flare Traversable LT?	Yes	N/A	Flare Traversable RT?	Yes
Yes	Landing Length (in)	95.0	Yes	DWS Provided?	Yes
Yes	Landing Width (in)	48.0	Yes	DWS Contrast?	Yes
Yes	Landing Slope (%)	1.5	Yes	DWS Length (in)	24.0
No	Landing X Slope (%)	4.1	Yes	DWS Full Width?	Yes
N/A	Landing Curb? (Y/N)	No	No	DWS Offset (in)	2.5
N/A	Shared Landing?	Yes			
Yes	Gutter Ponding?	No	Yes	Gutter Slope (%)	1.2
Yes	Gutter Lip Ht (in)	0.0	No	Gutter X Slope (%)	4.6
N/A	Painted X Walk1?	Yes	N/A	Painted X Walk2?	N/A
	X Walk 1 Direction	To NW		X Walk 2 Direction	N/A
N/A	X Walk 1 Width (in)	87.0	N/A	X Walk 2 Width (in)	N/A
	X Walk 1 Slope (%)	0.3		X Walk 2 Slope (%)	N/A
	X Walk 1 X Slope (%)	3.5		X Walk 2 X Slope (%)	N/A

Remove & Replace Entire Ramp.
Remove & Replace Gutter.
