Access Compliance Report
Public Rights-of-Way
(Curb Ramps)

Intersection ID: 42788	**Main Street:** CRUTCHFIELD_PL	**Cross Street:** SIDNEY_CREST_AV	**Location:** S
ADA ID: 18767CC6DAA4	**Ramp Type:** PerpDiag	**Initial Pass/Fail:** Fail	**Overall Compliance:** No	**Severity Score:** 58.75

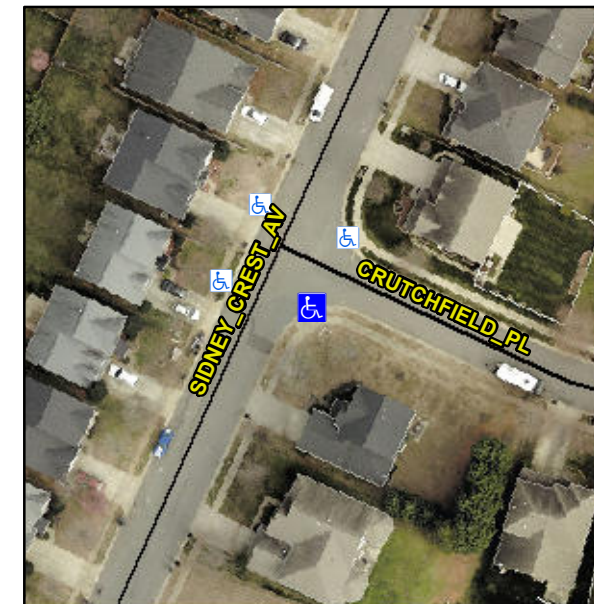
Not Found, R304.5.1, R304.2.2, R304.5.3

Compliance	Description	Data	Compliance	Description	Data
N/A	Ramp Length (in)	47.0	No	Ramp Slope (%)	13.1
No	Ramp Width (in)	45.0	No	Ramp XSlope (%)	7.7
N/A	Flare Type LT	N/A	N/A	Flare Type RT	N/A
N/A	Flare Slope LT (%)	N/A	N/A	Flare Slope RT (%)	N/A
N/A	Flare Traversable LT?	N/A	N/A	Flare Traversable RT?	N/A
N/A	Landing Length (in)	N/A	N/A	DWS Provided?	N/A
N/A	Landing Width (in)	N/A	N/A	DWS Contrast?	N/A
N/A	Landing Slope (%)	N/A	N/A	DWS Length (in)	N/A
N/A	Landing X Slope (%)	N/A	N/A	DWS Full Width?	N/A
N/A	Landing Curb? (Y/N)	N/A	N/A	DWS Offset (in)	N/A
N/A	Shared Landing?	N/A			
N/A	Gutter Ponding?	N/A	N/A	Gutter Slope (%)	N/A
N/A	Gutter Lip Ht (in)	N/A	N/A	Gutter X Slope (%)	N/A
N/A	Painted X Walk1?	No	N/A	Painted X Walk2?	No
	X Walk 1 Direction	To NE		X Walk 2 Direction	To NW
N/A	X Walk 1 Width (in)	N/A	N/A	X Walk 2 Width (in)	N/A
	X Walk 1 Slope (%)	5.4		X Walk 2 Slope (%)	4.9
	X Walk 1 X Slope (%)	8.6		X Walk 2 X Slope (%)	7.4

N/A	Ramp inside XWalk1?	N/A	N/A	Ramp inside XWalk2?	N/A
	Road Slope (%)	8.0	N/A	Clear Space?	N/A
	Road X Slope (%)	0.6	N/A	Clear Space to XWalk (in)	N/A
N/A	Any Obstructions?	N/A	N/A	Storm Grate/Utility Hazard?	N/A
	Obstruction Type			Storm Grate/Utility Type	
		N/A			N/A
			Yes	Surface Condition? (G/P)	Good

Remove & Replace Curb Ramp With Two New Directional Ramps or Equivalent.
