Access Compliance Report
Public Rights-of-Way
(Curb Ramps)

Intersection ID: 18131 **Main Street:** E_WOODLAWN_RD **Cross Street:** DARWIN_CR **Location:** SW

ADA ID: 18841402C127 **Ramp Type:** Perp **Initial Pass/Fail:** Fail **Overall Compliance:** No **Severity Score:** 18.75

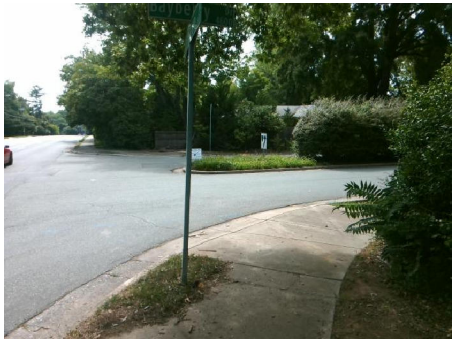
Not Found, R304.5.1, R304.5.3

Compliance	Description	Data	Compliance	Description	Data
N/A	Ramp Length (in)	87.0	Yes	Ramp Slope (%)	7.7
No	Ramp Width (in)	33.0	No	Ramp XSlope (%)	4.7
N/A	Flare Type LT	N/A	N/A	Flare Type RT	N/A
N/A	Flare Slope LT (%)	N/A	N/A	Flare Slope RT (%)	N/A
N/A	Flare Traversable LT?	N/A	N/A	Flare Traversable RT?	N/A
N/A	Landing Length (in)	N/A	N/A	DWS Provided?	N/A
N/A	Landing Width (in)	N/A	N/A	DWS Contrast?	N/A
N/A	Landing Slope (%)	N/A	N/A	DWS Length (in)	N/A
N/A	Landing X Slope (%)	N/A	N/A	DWS Full Width?	N/A
N/A	Landing Curb? (Y/N)	N/A	N/A	DWS Offset (in)	N/A
N/A	Shared Landing?	N/A			
N/A	Gutter Ponding?	N/A	N/A	Gutter Slope (%)	N/A
N/A	Gutter Lip Ht (in)	N/A	N/A	Gutter X Slope (%)	N/A
N/A	Painted X Walk1?	No	N/A	Painted X Walk2?	N/A
	X Walk 1 Direction	To E		X Walk 2 Direction	N/A
N/A	X Walk 1 Width (in)	N/A	N/A	X Walk 2 Width (in)	N/A
	X Walk 1 Slope (%)	0.8		X Walk 2 Slope (%)	N/A

Remove & Replace Entire Ramp.
