Access Compliance Report
Public Rights-of-Way
(Curb Ramps)

Intersection ID: 42773	**Main Street:** ERWIN_RIDGE_AV	**Cross Street:** SWANSONG_LN	**Location:** W
ADA ID: 18FD01709D24	**Ramp Type:** PerpDiag	**Initial Pass/Fail:** Fail	**Overall Compliance:** No	**Severity Score:** 8.75

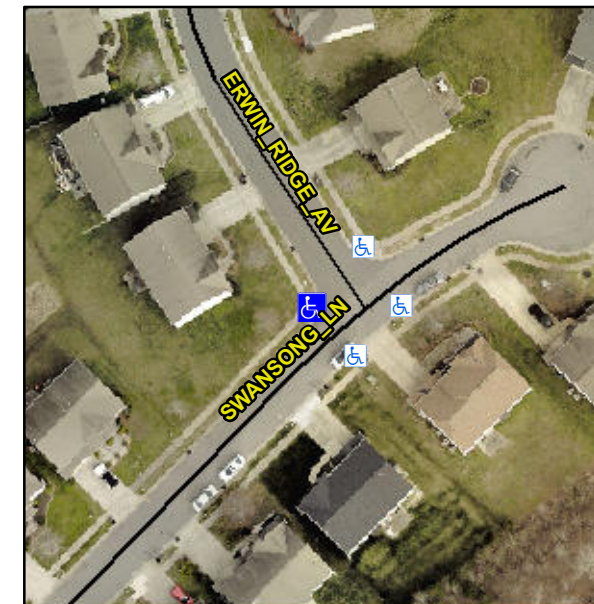
Not Found, R304.5.1

Compliance	Description	Data	Compliance	Description	Data
N/A	Ramp Length (in)	49.0	Yes	Ramp Slope (%)	7.3
No	Ramp Width (in)	47.0	Yes	Ramp XSlope (%)	0.5
N/A	Flare Type LT	N/A	N/A	Flare Type RT	N/A
N/A	Flare Slope LT (%)	N/A	N/A	Flare Slope RT (%)	N/A
N/A	Flare Traversable LT?	N/A	N/A	Flare Traversable RT?	N/A
N/A	Landing Length (in)	N/A	N/A	DWS Provided?	N/A
N/A	Landing Width (in)	N/A	N/A	DWS Contrast?	N/A
N/A	Landing Slope (%)	N/A	N/A	DWS Length (in)	N/A
N/A	Landing X Slope (%)	N/A	N/A	DWS Full Width?	N/A
N/A	Landing Curb? (Y/N)	N/A	N/A	DWS Offset (in)	N/A
N/A	Shared Landing?	N/A			
N/A	Gutter Ponding?	N/A	N/A	Gutter Slope (%)	N/A
N/A	Gutter Lip Ht (in)	N/A	N/A	Gutter X Slope (%)	N/A
N/A	Painted X Walk1?	No	N/A	Painted X Walk2?	No
	X Walk 1 Direction	To S		X Walk 2 Direction	To E
N/A	X Walk 1 Width (in)	N/A	N/A	X Walk 2 Width (in)	N/A
	X Walk 1 Slope (%)	2.9		X Walk 2 Slope (%)	1.4
	X Walk 1 X Slope (%)	2.3		X Walk 2 X Slope (%)	0.8

Remove & Replace Curb Ramp With Two New Directional Ramps or Equivalent.
