Access Compliance Report
Public Rights-of-Way
(Curb Ramps)

Intersection ID: 4530	Main Street: BROOKSHIRE_BV	Cross Street: MT_HOLLY-HUNTERSVILLE_RD	Location:	SW
ADA ID: 191394338E37	Ramp Type: BlendTrans1	Initial Pass/Fail: Fail	Overall Compliance: No	Severity Score: 8.75

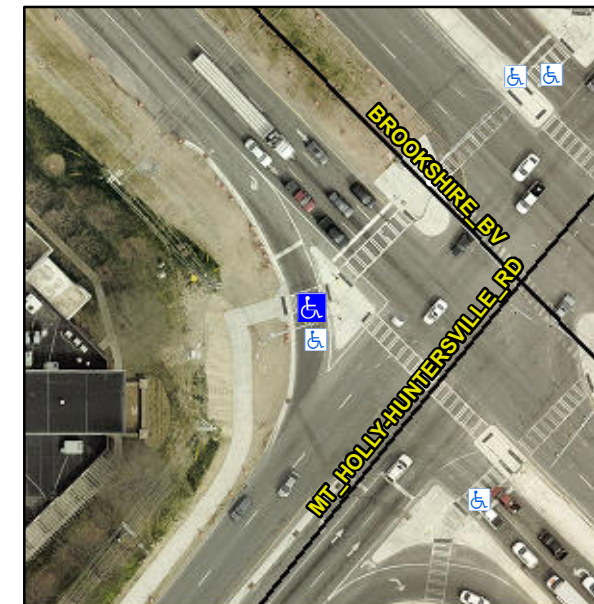
R304.5.1

Remove & Replace Curb Ramp With Two New Directional Ramps or Equivalent.
