Access Compliance Report

# Public Rights-of-Way
(Curb Ramps)

Intersection ID: 11129	Main Street: BECKWITH_PL	Cross Street: NEWELL_AV	Location:	SE
ADA ID: 19526B50A8BA	Ramp Type: Combination1	Initial Pass/Fail: Fail	Overall Compliance: No	Severity Score: 10

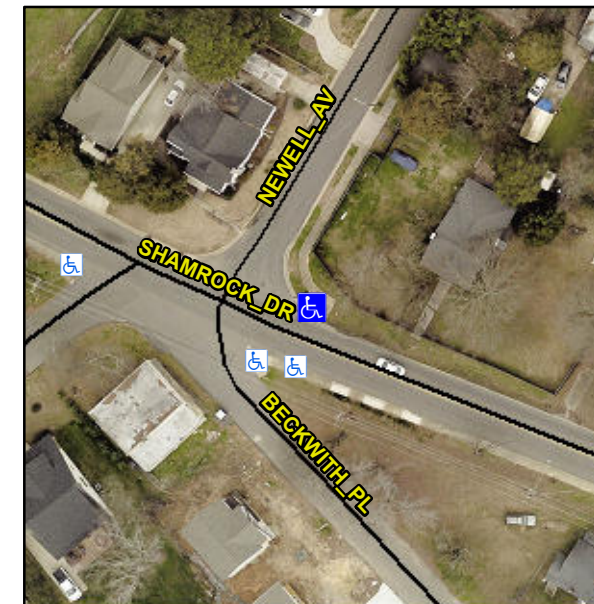
RT RP < 5%

Not Found, R304.5.1, R304.5.3

Compliance	Description	Data	Compliance	Description	Data
N/A	Ramp Length LT (in)	39.0	N/A	Ramp Length RT (in)	67.0
Yes	Ramp Width LT (in)	59.0	Yes	Ramp Width RT (in)	58.5
Yes	Ramp Slope LT (%)	5.7	Yes	Ramp Slope RT (%)	2.3
No	Ramp XSlope LT (%)	2.9	No	Ramp XSlope RT (%)	3.3
N/A	Ramp Length (in)	69.0	Yes	Ramp Slope (%)	6.1
No	Ramp Width (in)	46.0	No	Ramp XSlope (%)	4.0
N/A	Flare Type LT	N/A	N/A	Flare Type RT	N/A
N/A	Flare Slope LT (%)	N/A	N/A	Flare Slope RT (%)	N/A
N/A	Flare Traversable LT?	N/A	N/A	Flare Traversable RT?	N/A
N/A	Landing Length (in)	N/A	N/A	DWS Provided?	N/A
N/A	Landing Width (in)	N/A	N/A	DWS Contrast?	N/A
N/A	Landing Slope (%)	N/A	N/A	DWS Length (in)	N/A
N/A	Landing X Slope (%)	N/A	N/A	DWS Full Width?	N/A
N/A	Landing Curb? (Y/N)	N/A	N/A	DWS Offset (in)	N/A
N/A	Shared Landing?	N/A			
N/A	Gutter Ponding?	N/A	N/A	Gutter Slope (%)	N/A
N/A	Gutter Lip Ht (in)	N/A	N/A	Gutter X Slope (%)	N/A
N/A	Painted X Walk1?	No	N/A	Painted X Walk2?	N/A

Remove & Replace Entire Ramp.
