Access Compliance Report
Public Rights-of-Way
(Curb Ramps)

Intersection ID: 45246	Main Street: BEGONIA_DR	Cross Street: KODIAK_CT	Location: SW
ADA ID: 197FDAF82F2C	Ramp Type: BlendTrans1	Initial Pass/Fail: Fail Overall Compliance: No	Severity Score: 12.5

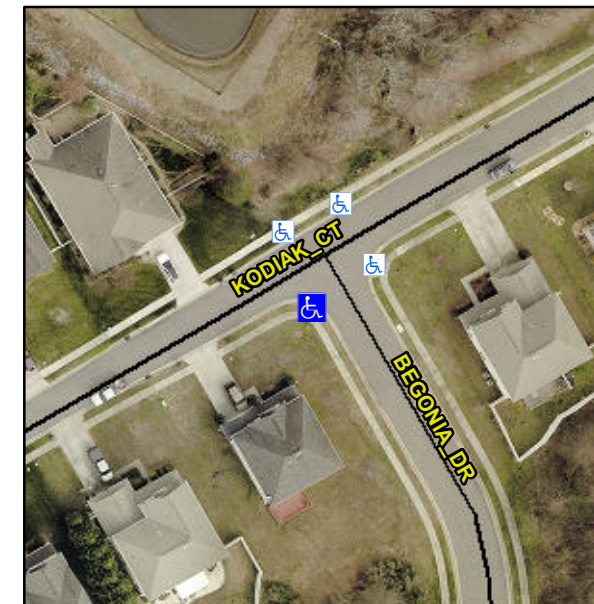
Not Found, R304.5.3

Compliance	Description	Data	Compliance	Description	Data
N/A	Ramp Length (in)	47.0	Yes	BlendTrans Slope (%)	4.3
Yes	Ramp Width (in)	48.0	No	BlendTrans XSlope (%)	6.8
N/A	Flare Type LT	N/A	N/A	Flare Type RT	N/A
N/A	Flare Slope LT (%)	N/A	N/A	Flare Slope RT (%)	N/A
N/A	Flare Traversable LT?	N/A	N/A	Flare Traversable RT?	N/A
N/A	Landing Length (in)	N/A	N/A	DWS Provided?	N/A
N/A	Landing Width (in)	N/A	N/A	DWS Contrast?	N/A
N/A	Landing Slope (%)	N/A	N/A	DWS Length (in)	N/A
N/A	Landing X Slope (%)	N/A	N/A	DWS Full Width?	N/A
N/A	Landing Curb? (Y/N)	N/A	N/A	DWS Offset (in)	N/A
N/A	Shared Landing?	N/A			
N/A	Gutter Ponding?	N/A	N/A	Gutter Slope (%)	N/A
N/A	Gutter Lip Ht (in)	N/A	N/A	Gutter X Slope (%)	N/A
N/A	Painted X Walk1?	No	N/A	Painted X Walk2?	No
	X Walk 1 Direction	To NE		X Walk 2 Direction	To NW
	X Walk 1 Width (in)	N/A		X Walk 2 Width (in)	N/A
	X Walk 1 Slope (%)	0.3		X Walk 2 Slope (%)	5.3
	X Walk 1 X Slope (%)	3.9		X Walk 2 X Slope (%)	3.1

N/A	Ramp inside XWalk1?	N/A	N/A	Ramp inside XWalk2?	N/A
	Road Slope (%)	4.2		Clear Space?	N/A
	Road X Slope (%)	0.7	N/A	Clear Space to XWalk (in)	N/A
N/A	Any Obstructions?	N/A	N/A	Storm Grate/Utility Hazard?	N/A
	Obstruction Type			Storm Grate/Utility Type	
N/A					N/A
			Yes	Surface Condition? (G/P)	Good
			No	Curb Slope (%)	16.0

Remove & Replace Curb Ramp With Two New Directional Ramps or Equivalent.
