# Access Compliance Report
Public Rights-of-Way
(Curb Ramps)

Intersection ID: 43227   **Main Street:** N_I-77_EXIT_5_RA   **Cross Street:** N_I-77_HY   **Location:** NE

ADA ID: 1A00F0BFD95D   **Ramp Type:** Perp   **Initial Pass/Fail:** Fail   **Overall Compliance:** No   **Severity Score:** 8.75

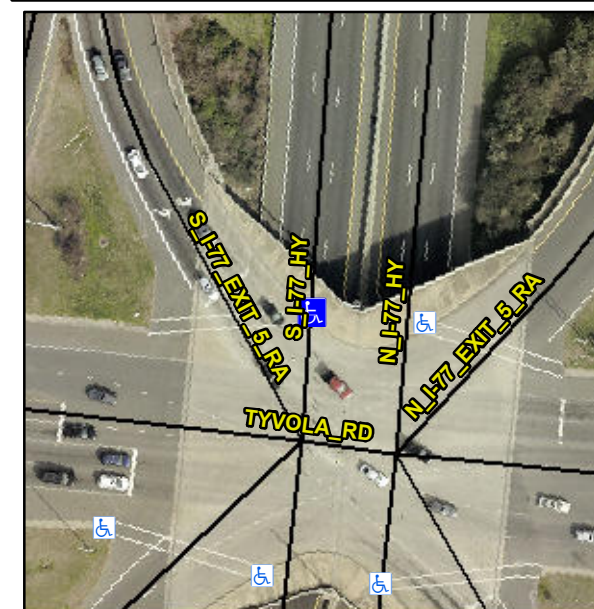
Not Found, R304.5.1

Compliance	Description	Data	Compliance	Description	Data
N/A	Ramp Length (in)	96.0	Yes	Ramp Slope (%)	7.1
No	Ramp Width (in)	39.0	Yes	Ramp XSlope (%)	1.7
N/A	Flare Type LT	N/A	N/A	Flare Type RT	N/A
N/A	Flare Slope LT (%)	N/A	N/A	Flare Slope RT (%)	N/A
N/A	Flare Traversable LT?	N/A	N/A	Flare Traversable RT?	N/A
N/A	Landing Length (in)	N/A	N/A	DWS Provided?	N/A
N/A	Landing Width (in)	N/A	N/A	DWS Contrast?	N/A
N/A	Landing Slope (%)	N/A	N/A	DWS Length (in)	N/A
N/A	Landing X Slope (%)	N/A	N/A	DWS Full Width?	N/A
N/A	Landing Curb? (Y/N)	N/A	N/A	DWS Offset (in)	N/A
N/A	Shared Landing?	N/A			
N/A	Gutter Ponding?	N/A	N/A	Gutter Slope (%)	N/A
N/A	Gutter Lip Ht (in)	N/A	N/A	Gutter X Slope (%)	N/A
N/A	Painted X Walk1?	Yes	N/A	Painted X Walk2?	N/A
	X Walk 1 Direction	To W		X Walk 2 Direction	N/A
N/A	X Walk 1 Width (in)	84.0	N/A	X Walk 2 Width (in)	N/A
	X Walk 1 Slope (%)	2.5		X Walk 2 Slope (%)	N/A
	X Walk 1 X Slope (%)	1.0		X Walk 2 X Slope (%)	N/A

Remove & Replace Entire Ramp.
