Access Compliance Report
Public Rights-of-Way
(Curb Ramps)

Intersection ID: 12828	**Main Street:** W_MOREHEAD_ST	**Cross Street:** S_CHURCH_ST	**Location:** W
ADA ID: 1A6A3EBB2DDA	**Ramp Type:** BlendTrans2	**Initial Pass/Fail:** Fail	**Overall Compliance:** No **Severity Score:** 8.75

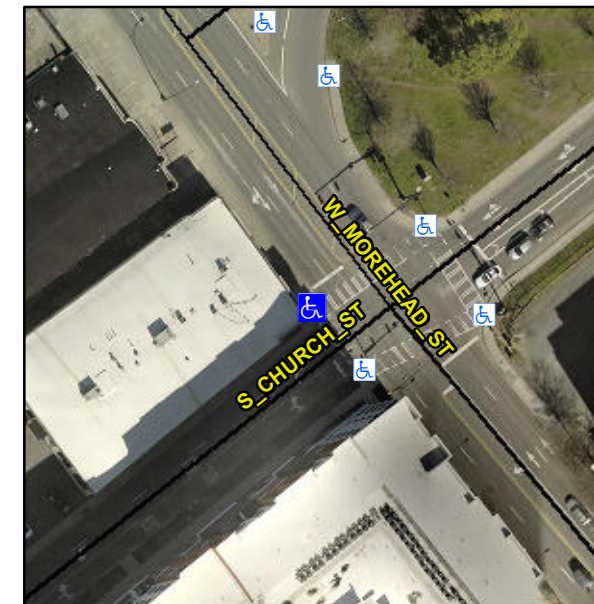
R304.5.1

Compliance	Description	Data	Compliance	Description	Data
N/A	Ramp Length (in)	62.0	Yes	BlendTrans Slope (%)	0.9
No	Ramp Width (in)	47.0	Yes	BlendTrans XSlope (%)	1.7
N/A	Flare Type LT	N/A	N/A	Flare Type RT	N/A
N/A	Flare Slope LT (%)	N/A	N/A	Flare Slope RT (%)	N/A
N/A	Flare Traversable LT?	N/A	N/A	Flare Traversable RT?	N/A
N/A	Landing Length (in)	N/A	N/A	DWS Provided?	N/A
N/A	Landing Width (in)	N/A	N/A	DWS Contrast?	N/A
N/A	Landing Slope (%)	N/A	N/A	DWS Length (in)	N/A
N/A	Landing X Slope (%)	N/A	N/A	DWS Full Width?	N/A
N/A	Landing Curb? (Y/N)	N/A	N/A	DWS Offset (in)	N/A
N/A	Shared Landing?	N/A			
N/A	Gutter Ponding?	N/A	N/A	Gutter Slope (%)	N/A
N/A	Gutter Lip Ht (in)	N/A	N/A	Gutter X Slope (%)	N/A
N/A	Painted X Walk1?	Yes	N/A	Painted X Walk2?	Yes
	X Walk 1 Direction	To SE		X Walk 2 Direction	To NE
	X Walk 1 Width (in)	99.0		X Walk 2 Width (in)	106.0
	X Walk 1 Slope (%)	2.5		X Walk 2 Slope (%)	1.2
	X Walk 1 X Slope (%)	2.8		X Walk 2 X Slope (%)	2.8

N/A	Ramp inside XWalk1?	Yes	N/A	Ramp inside XWalk2?	Yes
	Road Slope (%)	3.7		Clear Space?	N/A
	Road X Slope (%)	2.7	N/A	Clear Space to XWalk (in)	N/A
N/A	Any Obstructions?	N/A	N/A	Storm Grate/Utility Hazard?	N/A
	Obstruction Type			Storm Grate/Utility Type	
N/A					N/A
			Yes	Surface Condition? (G/P)	Good
			N/A	Curb Slope (%)	2.9

Possible Solutions:

Remove & Replace Curb Ramp With Two New Directional Ramps or Equivalent.
