Access Compliance Report
Public Rights-of-Way
(Curb Ramps)

Intersection ID: 17621	Main Street: CROYDON_RD	Cross Street: RIDGEWOOD_AV	Location:	NE
ADA ID: 1BFA9A716B75	Ramp Type: Directional1	Initial Pass/Fail: Fail	Overall Compliance: No	Severity Score: 1.25

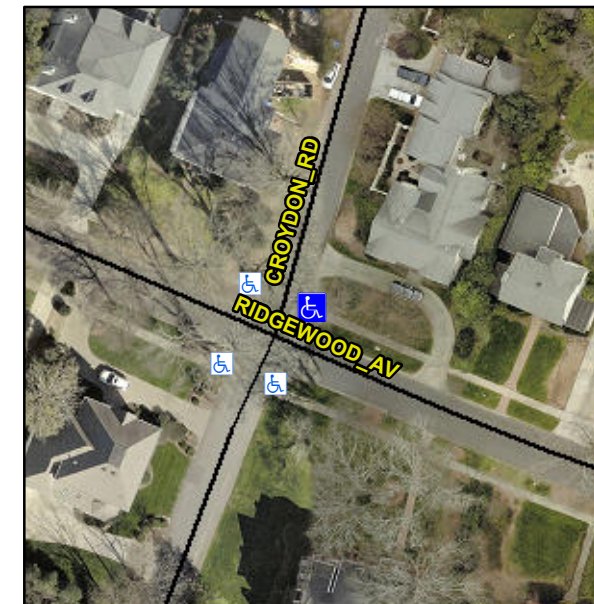
R304.5.3

Compliance	Description	Data	Compliance	Description	Data
	N/A	Ramp Length (in)	76.0	N/A	Grade Break?	N/A
	Yes	Ramp Width (in)	50.0	N/A	Grade Break Slope (%)	0.0
	Yes	Ramp Slope (%)	7.0	N/A	Grade Break XSlope (%)	0.0
	No	Ramp XSlope (%)	2.4			
	N/A	Flare Type LT	N/A	N/A	Flare Type RT	N/A
	N/A	Flare Slope LT (%)	N/A	N/A	Flare Slope RT (%)	0.0
	N/A	Flare Traversable LT?	N/A	N/A	Flare Traversable RT?	N/A
	N/A	Landing Length (in)	0.0	N/A	DWS Provided?	N/A
	N/A	Landing Width (in)	0.0	N/A	DWS Contrast?	N/A
	N/A	Landing Slope (%)	0.0	N/A	DWS Length (in)	N/A
	N/A	Landing X Slope (%)	0.0	N/A	DWS Full Width?	N/A
	N/A	Landing Curb? (Y/N)	N/A	N/A	DWS Offset LT (in)	N/A
	N/A	Shared Landing?	N/A	N/A	DWS Offset RT (in)	N/A
	N/A	Gutter Ponding?	0.0	N/A	Gutter Slope (%)	N/A
	N/A	Gutter Lip Ht (in)	0.0	N/A	Gutter X Slope (%)	N/A
	N/A	Painted X Walk1?	No		Road Slope (%)	1.2
		X Walk 1 Direction	To W		Road X Slope (%)	2.4
		X Walk 1 Width (in)	N/A		Clear Space?	N/A

Remove & Replace Entire Ramp.
