Access Compliance Report
Public Rights-of-Way
(Curb Ramps)

Intersection ID: 4004	**Main Street: DOWNING_CREEK_DR**	**Cross Street: POINTVIEW_PL**	**Location: S**
ADA ID: 1C12788BCA82	**Ramp Type: BlendTrans1**	**Initial Pass/Fail: Fail**	**Overall Compliance: No** / **Severity Score: 10**

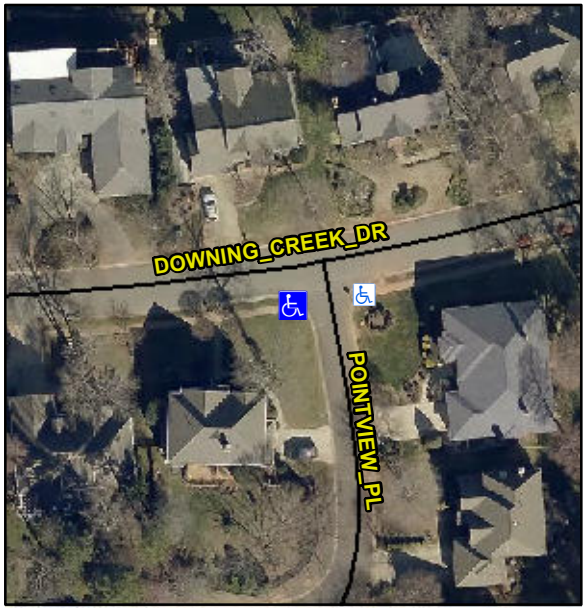
Not Found, R304.5.1, R304.5.3

Compliance	Description	Data	Compliance	Description	Data
N/A	Ramp Length (in)	49.0	Yes	BlendTrans Slope (%)	2.4
No	Ramp Width (in)	39.0	No	BlendTrans XSlope (%)	4.2
N/A	Flare Type LT	N/A	N/A	Flare Type RT	N/A
N/A	Flare Slope LT (%)	N/A	N/A	Flare Slope RT (%)	N/A
N/A	Flare Traversable LT?	N/A	N/A	Flare Traversable RT?	N/A
N/A	Landing Length (in)	N/A	N/A	DWS Provided?	N/A
N/A	Landing Width (in)	N/A	N/A	DWS Contrast?	N/A
N/A	Landing Slope (%)	N/A	N/A	DWS Length (in)	N/A
N/A	Landing X Slope (%)	N/A	N/A	DWS Full Width?	N/A
N/A	Landing Curb? (Y/N)	N/A	N/A	DWS Offset (in)	N/A
N/A	Shared Landing?	N/A			
N/A	Gutter Ponding?	N/A	N/A	Gutter Slope (%)	N/A
N/A	Gutter Lip Ht (in)	N/A	N/A	Gutter X Slope (%)	N/A
N/A	Painted X Walk1?	No	N/A	Painted X Walk2?	N/A
	X Walk 1 Direction	To NE		X Walk 2 Direction	N/A
	X Walk 1 Width (in)	N/A		X Walk 2 Width (in)	N/A
	X Walk 1 Slope (%)	0.8		X Walk 2 Slope (%)	N/A
	X Walk 1 X Slope (%)	4.2		X Walk 2 X Slope (%)	N/A

N/A	Ramp inside XWalk1?	N/A	N/A	Ramp inside XWalk2?	N/A
	Road Slope (%)	4.2		Clear Space?	N/A
	Road X Slope (%)	0.8	N/A	Clear Space to XWalk (in)	N/A
N/A	Any Obstructions?	N/A	N/A	Storm Grate/Utility Hazard?	N/A
	Obstruction Type			Storm Grate/Utility Type	
		N/A			N/A
			Yes	Surface Condition? (G/P)	Good
			No	Curb Slope (%)	17.6

Remove & Replace Curb Ramp With Two New Directional Ramps or Equivalent.
