Access Compliance Report
Public Rights-of-Way
(Curb Ramps)

Intersection ID: N/A | **Main Street:** IDLEWILD_RD | **Cross Street:** E_INDEPENDENCE_RA | **Location:** SE

ADA ID: 1C6761C32221 | **Ramp Type:** Perp | **Initial Pass/Fail:** Fail | **Overall Compliance:** No | **Severity Score:** 12.5

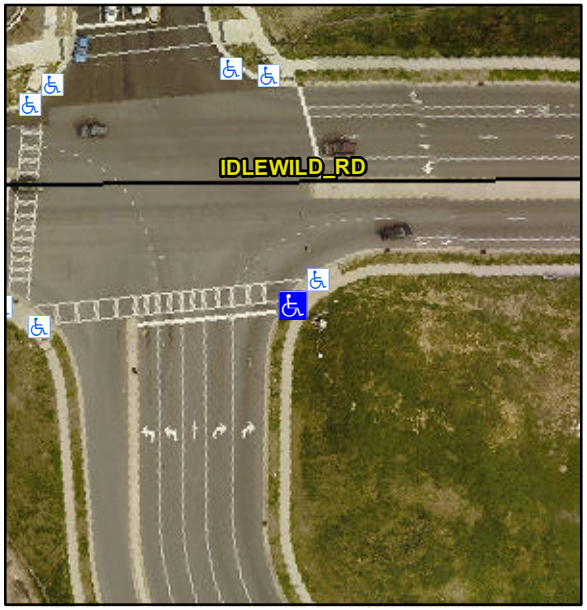
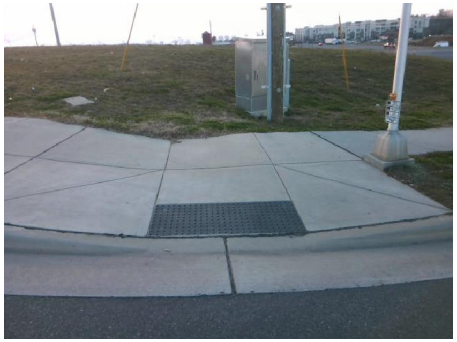
Not Found, R304.5.3

Compliance	Description	Data	Compliance	Description	Data
N/A	Ramp Length (in)	66.0	Yes	Ramp Slope (%)	7.6
Yes	Ramp Width (in)	59.0	No	Ramp XSlope (%)	6.9
N/A	Flare Type LT	N/A	N/A	Flare Type RT	N/A
N/A	Flare Slope LT (%)	N/A	N/A	Flare Slope RT (%)	N/A
N/A	Flare Traversable LT?	N/A	N/A	Flare Traversable RT?	N/A
N/A	Landing Length (in)	N/A	N/A	DWS Provided?	N/A
N/A	Landing Width (in)	N/A	N/A	DWS Contrast?	N/A
N/A	Landing Slope (%)	N/A	N/A	DWS Length (in)	N/A
N/A	Landing X Slope (%)	N/A	N/A	DWS Full Width?	N/A
N/A	Landing Curb? (Y/N)	N/A	N/A	DWS Offset (in)	N/A
N/A	Shared Landing?	N/A			
N/A	Gutter Ponding?	N/A	N/A	Gutter Slope (%)	N/A
N/A	Gutter Lip Ht (in)	N/A	N/A	Gutter X Slope (%)	N/A
N/A	Painted X Walk1?	Yes	N/A	Painted X Walk2?	N/A
	X Walk 1 Direction	To W		X Walk 2 Direction	N/A
N/A	X Walk 1 Width (in)	110.0	N/A	X Walk 2 Width (in)	N/A
	X Walk 1 Slope (%)	2.1		X Walk 2 Slope (%)	N/A

Remove & Replace Entire Ramp.
