# Access Compliance Report
Public Rights-of-Way
(Curb Ramps)

Intersection ID: 11660	Main Street: E_20TH_ST	Cross Street: HARRILL_ST	Location:	S
ADA ID: 1CBDAE84C67D	Ramp Type: PerpDiag	Initial Pass/Fail: Fail	Overall Compliance: No	Severity Score: 10

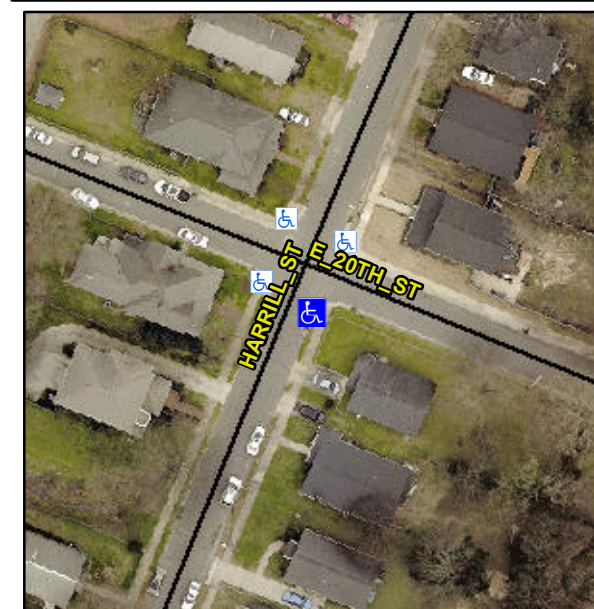
Not Found, R304.5.1, R304.5.3

Compliance	Description	Data	Compliance	Description	Data
N/A	Ramp Length (in)	25.0	Yes	Ramp Slope (%)	6.8
No	Ramp Width (in)	41.0	No	Ramp XSlope (%)	3.0
N/A	Flare Type LT	N/A	N/A	Flare Type RT	N/A
N/A	Flare Slope LT (%)	N/A	N/A	Flare Slope RT (%)	N/A
N/A	Flare Traversable LT?	N/A	N/A	Flare Traversable RT?	N/A
N/A	Landing Length (in)	N/A	N/A	DWS Provided?	N/A
N/A	Landing Width (in)	N/A	N/A	DWS Contrast?	N/A
N/A	Landing Slope (%)	N/A	N/A	DWS Length (in)	N/A
N/A	Landing X Slope (%)	N/A	N/A	DWS Full Width?	N/A
N/A	Landing Curb? (Y/N)	N/A	N/A	DWS Offset (in)	N/A
N/A	Shared Landing?	N/A			
N/A	Gutter Ponding?	N/A	N/A	Gutter Slope (%)	N/A
N/A	Gutter Lip Ht (in)	N/A	N/A	Gutter X Slope (%)	N/A
N/A	Painted X Walk1?	No	N/A	Painted X Walk2?	No
	X Walk 1 Direction	To NE		X Walk 2 Direction	To NW
N/A	X Walk 1 Width (in)	N/A	N/A	X Walk 2 Width (in)	N/A
	X Walk 1 Slope (%)	5.7		X Walk 2 Slope (%)	2.2
	X Walk 1 X Slope (%)	3.7		X Walk 2 X Slope (%)	3.6

Remove & Replace Curb Ramp With Two New Directional Ramps or Equivalent.
