Access Compliance Report
Public Rights-of-Way
(Curb Ramps)

Intersection ID: 14724	**Main Street: ALBEMARLE_RD**	**Cross Street: GUICE_CROSSING_LN**	**Location: NE**
ADA ID: 1D12A7EEB160	**Ramp Type: Perp**	**Initial Pass/Fail: Fail**	**Overall Compliance: No** / **Severity Score: 21.25**

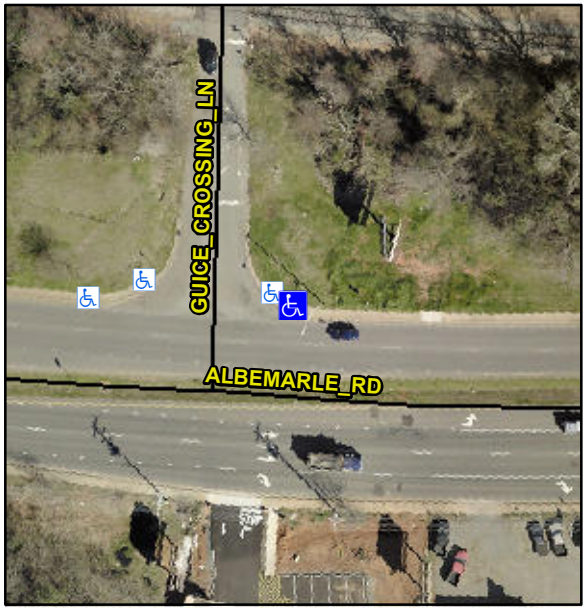
Not Found, R304.5.1, R304.2.2

Compliance	Description	Data	Compliance	Description	Data
N/A	Ramp Length (in)	59.5	No	Ramp Slope (%)	8.9
No	Ramp Width (in)	44.0	Yes	Ramp XSlope (%)	0.2
N/A	Flare Type LT	N/A	N/A	Flare Type RT	N/A
N/A	Flare Slope LT (%)	N/A	N/A	Flare Slope RT (%)	N/A
N/A	Flare Traversable LT?	N/A	N/A	Flare Traversable RT?	N/A
N/A	Landing Length (in)	N/A	N/A	DWS Provided?	N/A
N/A	Landing Width (in)	N/A	N/A	DWS Contrast?	N/A
N/A	Landing Slope (%)	N/A	N/A	DWS Length (in)	N/A
N/A	Landing X Slope (%)	N/A	N/A	DWS Full Width?	N/A
N/A	Landing Curb? (Y/N)	N/A	N/A	DWS Offset (in)	N/A
N/A	Shared Landing?	N/A			
N/A	Gutter Ponding?	N/A	N/A	Gutter Slope (%)	N/A
N/A	Gutter Lip Ht (in)	N/A	N/A	Gutter X Slope (%)	N/A
N/A	Painted X Walk1?	No	N/A	Painted X Walk2?	N/A
	X Walk 1 Direction	To S		X Walk 2 Direction	N/A
N/A	X Walk 1 Width (in)	N/A	N/A	X Walk 2 Width (in)	N/A
	X Walk 1 Slope (%)	2.3		X Walk 2 Slope (%)	N/A
	X Walk 1 X Slope (%)	0.9		X Walk 2 X Slope (%)	N/A

Remove & Replace Entire Ramp.
