Access Compliance Report
Public Rights-of-Way
(Curb Ramps)

Intersection ID: 21549 **Main Street:** S_TRYON_ST **Cross Street:** SANDY_PORTER_RD **Location:** E

ADA ID: 1DB719E54D6C **Ramp Type:** Perp **Initial Pass/Fail:** Fail **Overall Compliance:** No **Severity Score:** 13.75

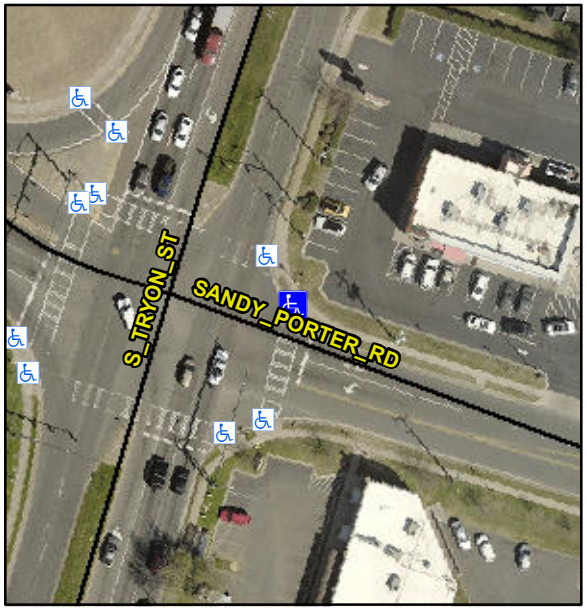
Not Found, R304.2.2, R304.5.3

Compliance	Description	Data	Compliance	Description	Data
N/A	Ramp Length (in)	47.0	No	Ramp Slope (%)	10.2
Yes	Ramp Width (in)	48.0	No	Ramp XSlope (%)	2.4
N/A	Flare Type LT	N/A	N/A	Flare Type RT	N/A
N/A	Flare Slope LT (%)	N/A	N/A	Flare Slope RT (%)	N/A
N/A	Flare Traversable LT?	N/A	N/A	Flare Traversable RT?	N/A
N/A	Landing Length (in)	N/A	N/A	DWS Provided?	N/A
N/A	Landing Width (in)	N/A	N/A	DWS Contrast?	N/A
N/A	Landing Slope (%)	N/A	N/A	DWS Length (in)	N/A
N/A	Landing X Slope (%)	N/A	N/A	DWS Full Width?	N/A
N/A	Landing Curb? (Y/N)	N/A	N/A	DWS Offset (in)	N/A
N/A	Shared Landing?	N/A			
N/A	Gutter Ponding?	N/A	N/A	Gutter Slope (%)	N/A
N/A	Gutter Lip Ht (in)	N/A	N/A	Gutter X Slope (%)	N/A
N/A	Painted X Walk1?	Yes	N/A	Painted X Walk2?	N/A
	X Walk 1 Direction	To S		X Walk 2 Direction	N/A
N/A	X Walk 1 Width (in)	112.0	N/A	X Walk 2 Width (in)	N/A
	X Walk 1 Slope (%)	1.4		X Walk 2 Slope (%)	N/A
	X Walk 1 X Slope (%)	2.2		X Walk 2 X Slope (%)	N/A

Remove & Replace Entire Ramp.
