Access Compliance Report
Public Rights-of-Way
(Curb Ramps)

Intersection ID: 43350	Main Street: FORESTRIDGE_COMMONS_DR	Cross Street: PROSPERITY_COMMONS_DR	Location:	S
ADA ID: 1E09962DA166	Ramp Type: PerpDiag	Initial Pass/Fail: Fail	Overall Compliance: No	Severity Score: 22.5

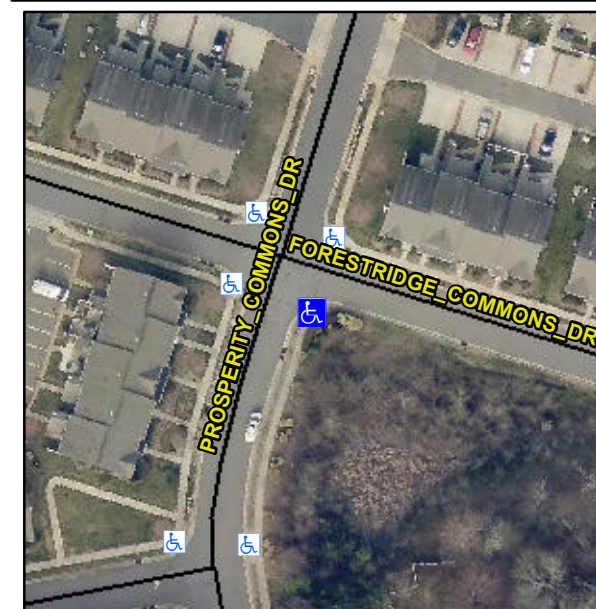
R304.5.1, R304.2.2, R304.5.3

Compliance	Description	Data	Compliance	Description	Data
N/A	Ramp Length (in)	47.0	No	Ramp Slope (%)	9.2
No	Ramp Width (in)	41.0	No	Ramp XSlope (%)	2.9
N/A	Flare Type LT	N/A	N/A	Flare Type RT	N/A
N/A	Flare Slope LT (%)	N/A	N/A	Flare Slope RT (%)	N/A
N/A	Flare Traversable LT?	N/A	N/A	Flare Traversable RT?	N/A
N/A	Landing Length (in)	N/A	N/A	DWS Provided?	N/A
N/A	Landing Width (in)	N/A	N/A	DWS Contrast?	N/A
N/A	Landing Slope (%)	N/A	N/A	DWS Length (in)	N/A
N/A	Landing X Slope (%)	N/A	N/A	DWS Full Width?	N/A
N/A	Landing Curb? (Y/N)	N/A	N/A	DWS Offset (in)	N/A
N/A	Shared Landing?	N/A			
N/A	Gutter Ponding?	N/A	N/A	Gutter Slope (%)	N/A
N/A	Gutter Lip Ht (in)	N/A	N/A	Gutter X Slope (%)	N/A
N/A	Painted X Walk1?	No	N/A	Painted X Walk2?	No
	X Walk 1 Direction	To NE		X Walk 2 Direction	To NW
N/A	X Walk 1 Width (in)	N/A	N/A	X Walk 2 Width (in)	N/A
	X Walk 1 Slope (%)	1.3		X Walk 2 Slope (%)	4.8
	X Walk 1 X Slope (%)	4.7		X Walk 2 X Slope (%)	1.0

N/A	Ramp inside XWalk1?	N/A	N/A	Ramp inside XWalk2?	N/A
	Road Slope (%)	2.4	N/A	Clear Space?	N/A
	Road X Slope (%)	0.6	N/A	Clear Space to XWalk (in)	N/A
N/A	Any Obstructions?	N/A	N/A	Storm Grate/Utility Hazard?	N/A
	Obstruction Type			Storm Grate/Utility Type	
N/A					N/A
			Yes	Surface Condition? (G/P)	Good

Remove & Replace Curb Ramp With Two New Directional Ramps or Equivalent.
