# Access Compliance Report
Public Rights-of-Way
(Curb Ramps)

Intersection ID: 27907   **Main Street:** BAY_HILL_CLUB_DR   **Cross Street:** COLONIAL_COUNTRY_LN   **Location:** NE

ADA ID: 1E3F0ACFF396   **Ramp Type:** Perp   **Initial Pass/Fail:** Pass   **Overall Compliance:** No   **Severity Score:** 10

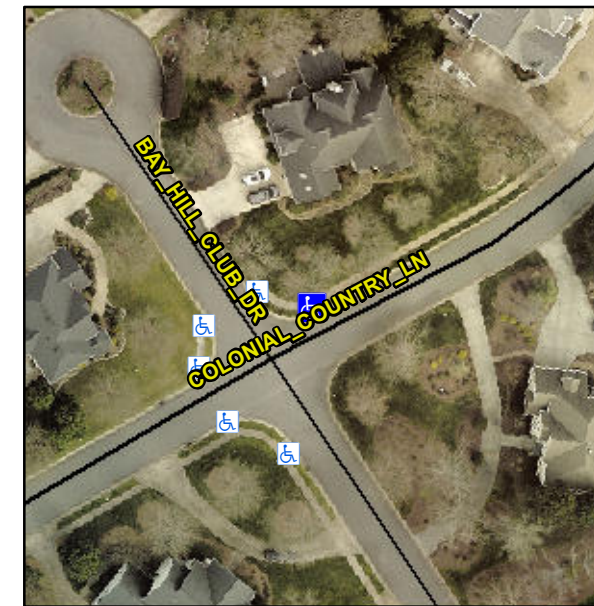
Not Found, R304.2.1, R304.2.2-Perp, R304.3.2-Para, R305, R304.5.3

Compliance	Description	Data	Compliance	Description	Data
N/A	Ramp Length (in)	48.0	Yes	Ramp Slope (%)	5.8
Yes	Ramp Width (in)	78.0	Yes	Ramp XSlope (%)	1.7
N/A	Flare Type LT	Sloped	N/A	Flare Type RT	N/A
N/A	Flare Slope LT (%)	1.4	N/A	Flare Slope RT (%)	4.7
N/A	Flare Traversable LT?	No	N/A	Flare Traversable RT?	No
No	Landing Length (in)	47.0	No	DWS Provided?	No
Yes	Landing Width (in)	85.0	N/A	DWS Contrast?	No
No	Landing Slope (%)	2.6	N/A	DWS Length (in)	N/A
Yes	Landing X Slope (%)	0.8	N/A	DWS Full Width?	No
N/A	Landing Curb? (Y/N)	No	N/A	DWS Offset (in)	N/A
N/A	Shared Landing?	No			
Yes	Gutter Ponding?	No	Yes	Gutter Slope (%)	4.3
Yes	Gutter Lip Ht (in)	0.0	No	Gutter X Slope (%)	2.2
N/A	Painted X Walk1?	No	N/A	Painted X Walk2?	N/A
	X Walk 1 Direction	To SE		X Walk 2 Direction	N/A
N/A	X Walk 1 Width (in)	N/A	N/A	X Walk 2 Width (in)	N/A
	X Walk 1 Slope (%)	3.4		X Walk 2 Slope (%)	N/A
	X Walk 1 X Slope (%)	0.4		X Walk 2 X Slope (%)	N/A

N/A	Ramp inside XWalk1?	N/A	N/A	Ramp inside XWalk2?	N/A
	Road Slope (%)	N/A	N/A	Clear Space?	Yes
	Road X Slope (%)	N/A	N/A	Clear Space to XWalk (in)	N/A
Yes	Any Obstructions?	No	Yes	Storm Grate/Utility Hazard?	No
	Obstruction Type			Storm Grate/Utility Type	
N/A					N/A
			Yes	Surface Condition? (G/P)	Good

Remove & Replace Entire Ramp.
Remove & Replace Gutter.
