# Access Compliance Report

# Public Rights-of-Way
# (Curb Ramps)

| Intersection ID: 31213 | Main Street: MANGLA_DR | Cross Street: MOUNTAIN_TRAIL_DR | Location: W |
| ADA ID: 1E5A34B1B78C | Ramp Type: PerpDiag | Initial Pass/Fail: Fail | Overall Compliance: No | Severity Score: 18.75 |

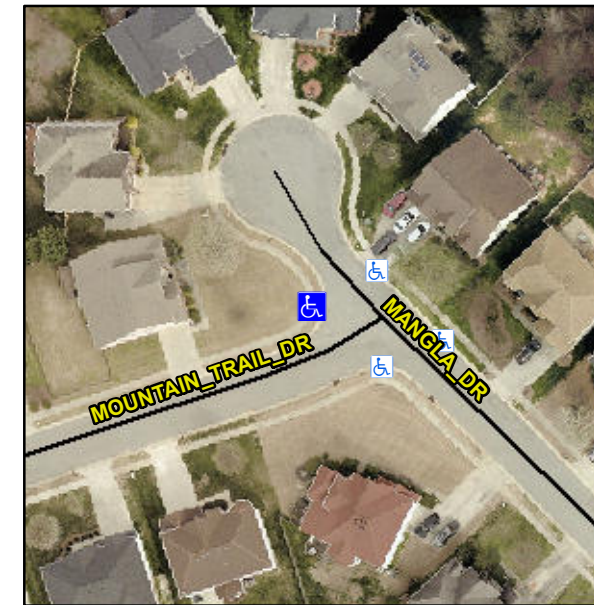
**R304.5.1, R304.5.3**

| Compliance | Description | Data | Compliance | Description | Data |
|---|---|---|---|---|---|
| N/A | Ramp Length (in) | 53.0 | Yes | Ramp Slope (%) | 6.9 |
| No | Ramp Width (in) | 33.0 | No | Ramp XSlope (%) | 2.4 |

**Remove & Replace Curb Ramp With Two New Directional Ramps or Equivalent.**
