# Access Compliance Report
Public Rights-of-Way
(Curb Ramps)

Intersection ID: 22474	Main Street: DENMARK_RD	Cross Street: E_HEBRON_ST	Location:	NE
ADA ID: 1EF9BC5E98D6	Ramp Type: PerpDiag	Initial Pass/Fail: Fail	Overall Compliance: No	Severity Score: 33.75

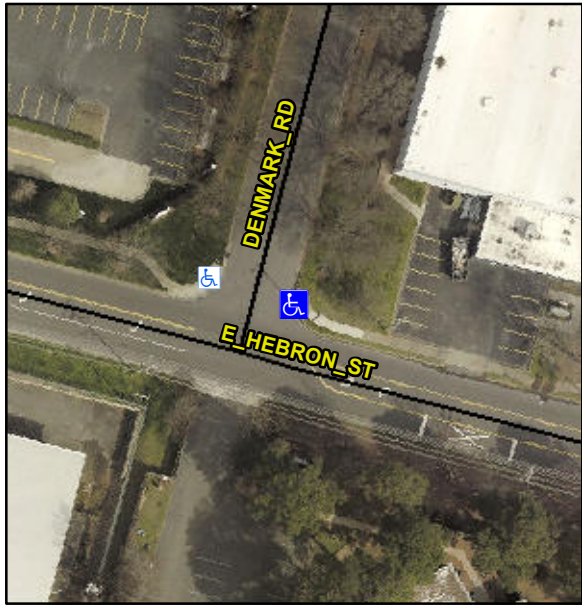
Not Found, R304.5.1, R304.2.2, R304.5.3

Compliance	Description	Data	Compliance	Description	Data
N/A	Ramp Length (in)	89.5	No	Ramp Slope (%)	8.9
No	Ramp Width (in)	43.0	No	Ramp XSlope (%)	5.6
N/A	Flare Type LT	N/A	N/A	Flare Type RT	N/A
N/A	Flare Slope LT (%)	N/A	N/A	Flare Slope RT (%)	N/A
N/A	Flare Traversable LT?	N/A	N/A	Flare Traversable RT?	N/A
N/A	Landing Length (in)	N/A	N/A	DWS Provided?	N/A
N/A	Landing Width (in)	N/A	N/A	DWS Contrast?	N/A
N/A	Landing Slope (%)	N/A	N/A	DWS Length (in)	N/A
N/A	Landing X Slope (%)	N/A	N/A	DWS Full Width?	N/A
N/A	Landing Curb? (Y/N)	N/A	N/A	DWS Offset (in)	N/A
N/A	Shared Landing?	N/A			
N/A	Gutter Ponding?	N/A	N/A	Gutter Slope (%)	N/A
N/A	Gutter Lip Ht (in)	N/A	N/A	Gutter X Slope (%)	N/A
N/A	Painted X Walk1?	No	N/A	Painted X Walk2?	No
	X Walk 1 Direction	To NW		X Walk 2 Direction	To SW
N/A	X Walk 1 Width (in)	N/A	N/A	X Walk 2 Width (in)	N/A
	X Walk 1 Slope (%)	2.2		X Walk 2 Slope (%)	7.3
	X Walk 1 X Slope (%)	4.3		X Walk 2 X Slope (%)	1.4

N/A	Ramp inside XWalk1?	N/A	N/A	Ramp inside XWalk2?	N/A
	Road Slope (%)	2.2	N/A	Clear Space?	N/A
	Road X Slope (%)	5.1	N/A	Clear Space to XWalk (in)	N/A
N/A	Any Obstructions?	N/A	N/A	Storm Grate/Utility Hazard?	N/A
	Obstruction Type			Storm Grate/Utility Type	
N/A					N/A
			Yes	Surface Condition? (G/P)	Good

Remove & Replace Curb Ramp With Two New Directional Ramps or Equivalent.
