Access Compliance Report
Public Rights-of-Way
(Curb Ramps)

Intersection ID: 53456	Main Street: OYSTER_LN	Cross Street: EASTFIELD_RD	Location:	N
ADA ID: 201B877FF3ED	Ramp Type: Perp	Initial Pass/Fail: Pass	Overall Compliance: No	Severity Score: 5

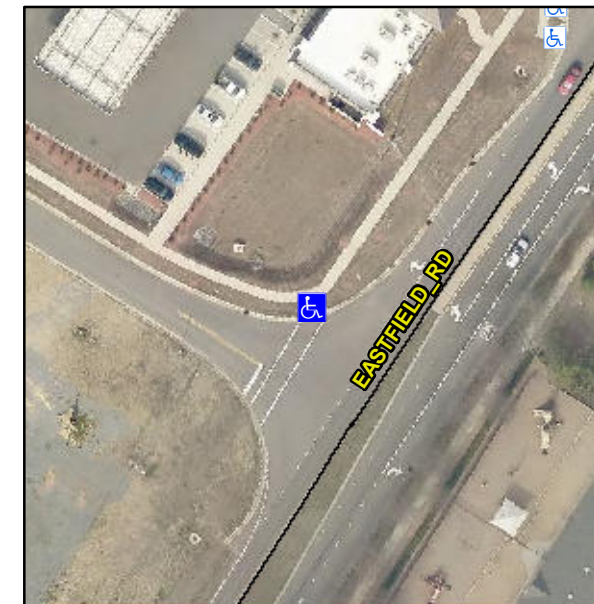
Not Found, R304.2.2-Perp, R304.3.2-Para, R305.2, R304.5.4

Compliance	Description	Data	Compliance	Description	Data
N/A	Ramp Length (in)	96.0	Yes	Ramp Slope (%)	7.8
Yes	Ramp Width (in)	48.0	Yes	Ramp XSlope (%)	1.0
N/A	Flare Type LT	Sloped	N/A	Flare Type RT	N/A
N/A	Flare Slope LT (%)	8.7	N/A	Flare Slope RT (%)	7.5
N/A	Flare Traversable LT?	No	N/A	Flare Traversable RT?	No
Yes	Landing Length (in)	60.0	Yes	DWS Provided?	Yes
Yes	Landing Width (in)	56.0	Yes	DWS Contrast?	Yes
No	Landing Slope (%)	3.0	Yes	DWS Length (in)	24.0
Yes	Landing X Slope (%)	1.5	Yes	DWS Full Width?	Yes
N/A	Landing Curb? (Y/N)	No	No	DWS Offset (in)	4.5
N/A	Shared Landing?	No			
Yes	Gutter Ponding?	No	No	Gutter Slope (%)	7.1
Yes	Gutter Lip Ht (in)	0.0	Yes	Gutter X Slope (%)	0.3
N/A	Painted X Walk1?	Yes	N/A	Painted X Walk2?	N/A
	X Walk 1 Direction	To SW		X Walk 2 Direction	N/A
N/A	X Walk 1 Width (in)	111.0	N/A	X Walk 2 Width (in)	N/A
	X Walk 1 Slope (%)	1.7		X Walk 2 Slope (%)	N/A
	X Walk 1 X Slope (%)	0.5		X Walk 2 X Slope (%)	N/A

Remove & Replace Entire Ramp.
Remove & Replace Gutter.
