Access Compliance Report
Public Rights-of-Way
(Curb Ramps)

Intersection ID: 5976	**Main Street: MOUNT_HOLLY_RD**	**Cross Street: CHATTAROY_DR**	**Location: N**
ADA ID: 208ED61AEA24	**Ramp Type: Perp**	**Initial Pass/Fail: Fail**	**Overall Compliance: No**	**Severity Score: 26.25**

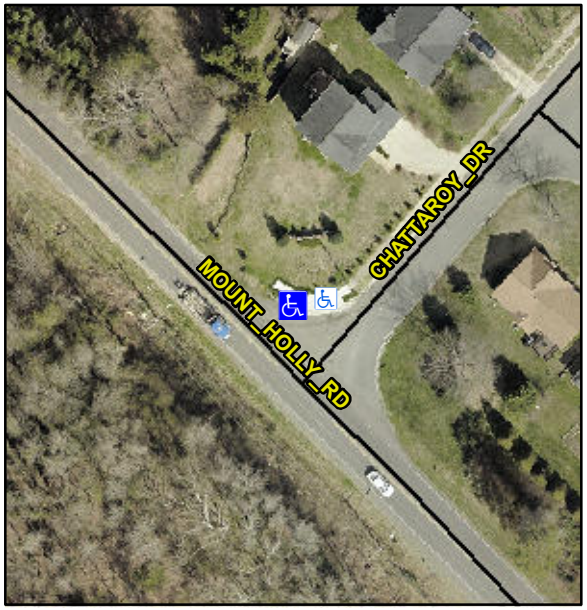
Not Found, R304.2.2

Compliance	Description	Data	Compliance	Description	Data
N/A	Ramp Length (in)	47.5	No	Ramp Slope (%)	16.3
Yes	Ramp Width (in)	60.0	Yes	Ramp XSlope (%)	3.4
N/A	Flare Type LT	N/A	N/A	Flare Type RT	N/A
N/A	Flare Slope LT (%)	N/A	N/A	Flare Slope RT (%)	N/A
N/A	Flare Traversable LT?	N/A	N/A	Flare Traversable RT?	N/A
N/A	Landing Length (in)	N/A	N/A	DWS Provided?	N/A
N/A	Landing Width (in)	N/A	N/A	DWS Contrast?	N/A
N/A	Landing Slope (%)	N/A	N/A	DWS Length (in)	N/A
N/A	Landing X Slope (%)	N/A	N/A	DWS Full Width?	N/A
N/A	Landing Curb? (Y/N)	N/A	N/A	DWS Offset (in)	N/A
N/A	Shared Landing?	N/A			
N/A	Gutter Ponding?	N/A	N/A	Gutter Slope (%)	N/A
N/A	Gutter Lip Ht (in)	N/A	N/A	Gutter X Slope (%)	N/A
N/A	Painted X Walk1?	No	N/A	Painted X Walk2?	N/A
	X Walk 1 Direction	To SW		X Walk 2 Direction	N/A
N/A	X Walk 1 Width (in)	N/A	N/A	X Walk 2 Width (in)	N/A
	X Walk 1 Slope (%)	3.3		X Walk 2 Slope (%)	N/A
	X Walk 1 X Slope (%)	4.2		X Walk 2 X Slope (%)	N/A

Remove & Replace Entire Ramp.
