Access Compliance Report
Public Rights-of-Way
(Curb Ramps)

Intersection ID: 15409	**Main Street: LEDGEWOOD_LN**	**Cross Street: SARAH_MARKS_AV**	**Location: W**
ADA ID: 20940AC8BBF7	**Ramp Type: Perp**	**Initial Pass/Fail: Fail**	**Overall Compliance: No** / **Severity Score: 46.25**

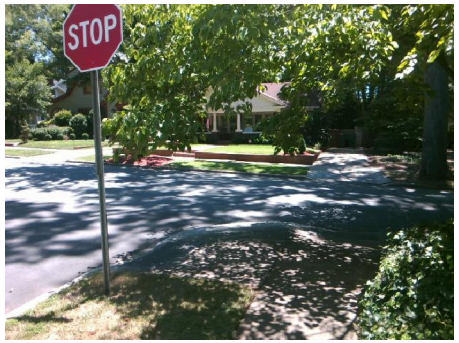
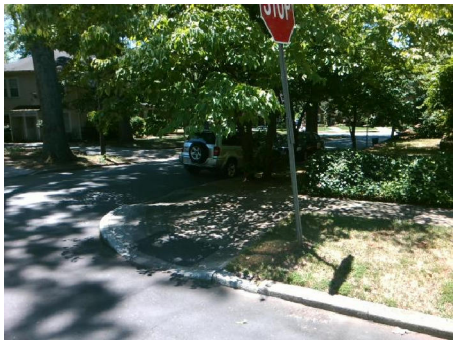
Not Found, R304.5.1, R304.2.2, R304.5.3

Compliance	Description	Data	Compliance	Description	Data
N/A	Ramp Length (in)	77.0	No	Ramp Slope (%)	9.3
No	Ramp Width (in)	40.0	No	Ramp XSlope (%)	8.4
N/A	Flare Type LT	N/A	N/A	Flare Type RT	N/A
N/A	Flare Slope LT (%)	N/A	N/A	Flare Slope RT (%)	N/A
N/A	Flare Traversable LT?	N/A	N/A	Flare Traversable RT?	N/A
N/A	Landing Length (in)	N/A	N/A	DWS Provided?	N/A
N/A	Landing Width (in)	N/A	N/A	DWS Contrast?	N/A
N/A	Landing Slope (%)	N/A	N/A	DWS Length (in)	N/A
N/A	Landing X Slope (%)	N/A	N/A	DWS Full Width?	N/A
N/A	Landing Curb? (Y/N)	N/A	N/A	DWS Offset (in)	N/A
N/A	Shared Landing?	N/A			
N/A	Gutter Ponding?	N/A	N/A	Gutter Slope (%)	N/A
N/A	Gutter Lip Ht (in)	N/A	N/A	Gutter X Slope (%)	N/A
N/A	Painted X Walk1?	No	N/A	Painted X Walk2?	N/A
	X Walk 1 Direction	To NE		X Walk 2 Direction	N/A
N/A	X Walk 1 Width (in)	N/A	N/A	X Walk 2 Width (in)	N/A
	X Walk 1 Slope (%)	4.8		X Walk 2 Slope (%)	N/A

X Walk 1 X Slope (%)	1.6		X Walk 2 X Slope (%)	N/A
N/A	Ramp inside XWalk1?	N/A	N/A	Ramp inside XWalk2?	N/A
	Road Slope (%)	N/A	N/A	Clear Space?	N/A
	Road X Slope (%)	N/A	N/A	Clear Space to XWalk (in)	N/A
N/A	Any Obstructions?	N/A	N/A	Storm Grate/Utility Hazard?	N/A
	Obstruction Type			Storm Grate/Utility Type	
		N/A			N/A
			Yes	Surface Condition? (G/P)	Good

Remove & Replace Entire Ramp.
