Access Compliance Report
Public Rights-of-Way
(Curb Ramps)

Intersection ID: 11414 **Main Street:** LIBETH_ST **Cross Street:** SHAMROCK_DR **Location:** SW

ADA ID: 21292B5031A2 **Ramp Type:** BlendTrans2 **Initial Pass/Fail:** Fail **Overall Compliance:** No **Severity Score:** 10

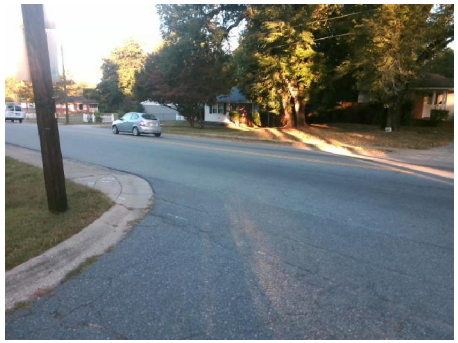
Not Found, R304.5.1

Compliance	Description	Data	Compliance	Description	Data
N/A	Ramp Length (in)	27.0	Yes	BlendTrans Slope (%)	4.4
No	Ramp Width (in)	42.0	Yes	BlendTrans XSlope (%)	2.5
N/A	Flare Type LT	N/A	N/A	Flare Type RT	N/A
N/A	Flare Slope LT (%)	N/A	N/A	Flare Slope RT (%)	N/A
N/A	Flare Traversable LT?	N/A	N/A	Flare Traversable RT?	N/A
N/A	Landing Length (in)	N/A	N/A	DWS Provided?	N/A
N/A	Landing Width (in)	N/A	N/A	DWS Contrast?	N/A
N/A	Landing Slope (%)	N/A	N/A	DWS Length (in)	N/A
N/A	Landing X Slope (%)	N/A	N/A	DWS Full Width?	N/A
N/A	Landing Curb? (Y/N)	N/A	N/A	DWS Offset (in)	N/A
N/A	Shared Landing?	N/A			
N/A	Gutter Ponding?	N/A	N/A	Gutter Slope (%)	N/A
N/A	Gutter Lip Ht (in)	N/A	N/A	Gutter X Slope (%)	N/A
N/A	Painted X Walk1?	No	N/A	Painted X Walk2?	N/A
	X Walk 1 Direction	To NW		X Walk 2 Direction	N/A
	X Walk 1 Width (in)	N/A		X Walk 2 Width (in)	N/A
	X Walk 1 Slope (%)	2.9		X Walk 2 Slope (%)	N/A

X Walk 1 X Slope (%)	3.6		X Walk 2 X Slope (%)	N/A
N/A	Ramp inside XWalk1?	N/A	N/A	Ramp inside XWalk2?	N/A
	Road Slope (%)	3.6		Clear Space?	N/A
	Road X Slope (%)	2.9	N/A	Clear Space to XWalk (in)	N/A
N/A	Any Obstructions?	N/A	N/A	Storm Grate/Utility Hazard?	N/A
	Obstruction Type			Storm Grate/Utility Type	
		N/A			N/A
			Yes	Surface Condition? (G/P)	Good
			No	Curb Slope (%)	10.4

Remove & Replace Curb Ramp With Two New Directional Ramps or Equivalent.
