Access Compliance Report
Public Rights-of-Way
(Curb Ramps)

Intersection ID: 47643 **Main Street:** BAMBURGH_CT **Cross Street:** WESTON_WOODS_LN **Location:** SW

ADA ID: 217D046332F2 **Ramp Type:** PerpDiag **Initial Pass/Fail:** Fail **Overall Compliance:** No **Severity Score:** 21.25

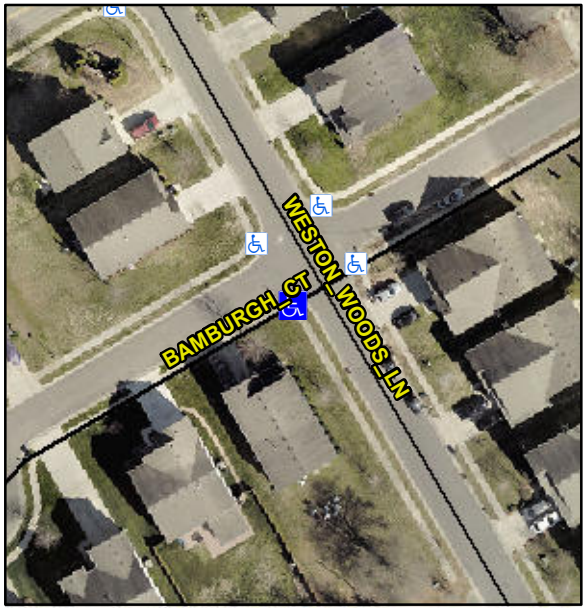
R304.5.1, R304.5.3

Compliance	Description	Data	Compliance	Description	Data
N/A	Ramp Length (in)	47.0	Yes	Ramp Slope (%)	7.9
No	Ramp Width (in)	47.0	No	Ramp XSlope (%)	5.5
N/A	Flare Type LT	N/A	N/A	Flare Type RT	N/A
N/A	Flare Slope LT (%)	N/A	N/A	Flare Slope RT (%)	N/A
N/A	Flare Traversable LT?	N/A	N/A	Flare Traversable RT?	N/A
N/A	Landing Length (in)	N/A	N/A	DWS Provided?	N/A
N/A	Landing Width (in)	N/A	N/A	DWS Contrast?	N/A
N/A	Landing Slope (%)	N/A	N/A	DWS Length (in)	N/A
N/A	Landing X Slope (%)	N/A	N/A	DWS Full Width?	N/A
N/A	Landing Curb? (Y/N)	N/A	N/A	DWS Offset (in)	N/A
N/A	Shared Landing?	N/A			
N/A	Gutter Ponding?	N/A	N/A	Gutter Slope (%)	N/A
N/A	Gutter Lip Ht (in)	N/A	N/A	Gutter X Slope (%)	N/A
N/A	Painted X Walk1?	No	N/A	Painted X Walk2?	No
	X Walk 1 Direction	To NE		X Walk 2 Direction	To NW
N/A	X Walk 1 Width (in)	N/A	N/A	X Walk 2 Width (in)	N/A
	X Walk 1 Slope (%)	2.8		X Walk 2 Slope (%)	0.3
	X Walk 1 X Slope (%)	0.2		X Walk 2 X Slope (%)	6.5

Remove & Replace Curb Ramp With Two New Directional Ramps or Equivalent.
