Access Compliance Report
Public Rights-of-Way
(Curb Ramps)

Intersection ID: 46187	Main Street: YAUPON_RD	Cross Street: FERNSPRAY_RD	Location:	SE
ADA ID: 22A592B43088	Ramp Type: BlendTrans1	Initial Pass/Fail: Fail	Overall Compliance: No	Severity Score: 33.75

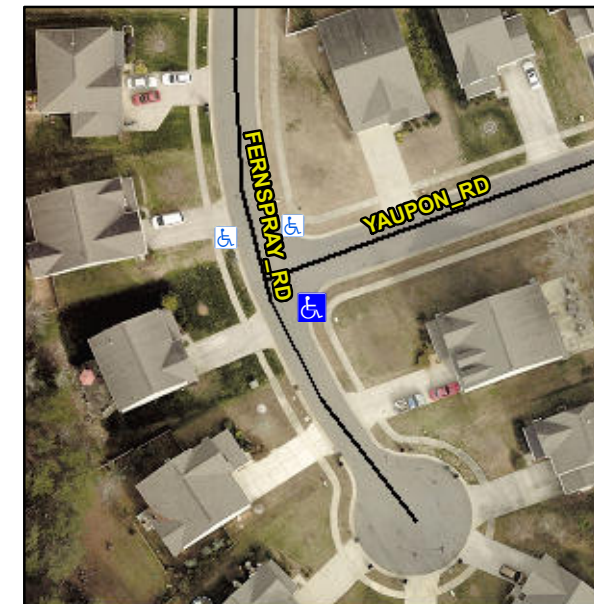
Not Found, R304.5.1, R304.5.3

Compliance	Description	Data	Compliance	Description	Data
N/A	Ramp Length (in)	75.0	Yes	BlendTrans Slope (%)	1.8
No	Ramp Width (in)	47.5	No	BlendTrans XSlope (%)	7.8
N/A	Flare Type LT	N/A	N/A	Flare Type RT	N/A
N/A	Flare Slope LT (%)	N/A	N/A	Flare Slope RT (%)	N/A
N/A	Flare Traversable LT?	N/A	N/A	Flare Traversable RT?	N/A
N/A	Landing Length (in)	N/A	N/A	DWS Provided?	N/A
N/A	Landing Width (in)	N/A	N/A	DWS Contrast?	N/A
N/A	Landing Slope (%)	N/A	N/A	DWS Length (in)	N/A
N/A	Landing X Slope (%)	N/A	N/A	DWS Full Width?	N/A
N/A	Landing Curb? (Y/N)	N/A	N/A	DWS Offset (in)	N/A
N/A	Shared Landing?	N/A			
N/A	Gutter Ponding?	N/A	N/A	Gutter Slope (%)	N/A
N/A	Gutter Lip Ht (in)	N/A	N/A	Gutter X Slope (%)	N/A
N/A	Painted X Walk1?	No	N/A	Painted X Walk2?	No
	X Walk 1 Direction	To N		X Walk 2 Direction	To W
	X Walk 1 Width (in)	N/A		X Walk 2 Width (in)	N/A
	X Walk 1 Slope (%)	0.5		X Walk 2 Slope (%)	3.6
	X Walk 1 X Slope (%)	7.4		X Walk 2 X Slope (%)	2.7

N/A	Ramp inside XWalk1?	N/A	N/A	Ramp inside XWalk2?	N/A
	Road Slope (%)	4.3	N/A	Clear Space?	N/A
	Road X Slope (%)	3.6	N/A	Clear Space to XWalk (in)	N/A
N/A	Any Obstructions?	N/A	N/A	Storm Grate/Utility Hazard?	N/A
	Obstruction Type			Storm Grate/Utility Type	
N/A					N/A
			Yes	Surface Condition? (G/P)	Good
			No	Curb Slope (%)	34.9

Remove & Replace Curb Ramp With Two New Directional Ramps or Equivalent.
