Access Compliance Report
Public Rights-of-Way
(Curb Ramps)

Intersection ID: N/A	Main Street: CALDWELL_RD	Cross Street: SUNBURST_LN	Location:	SE
ADA ID: 22E9091EF3F0	Ramp Type: PerpDiag	Initial Pass/Fail: Fail	Overall Compliance: No	Severity Score: 21.25

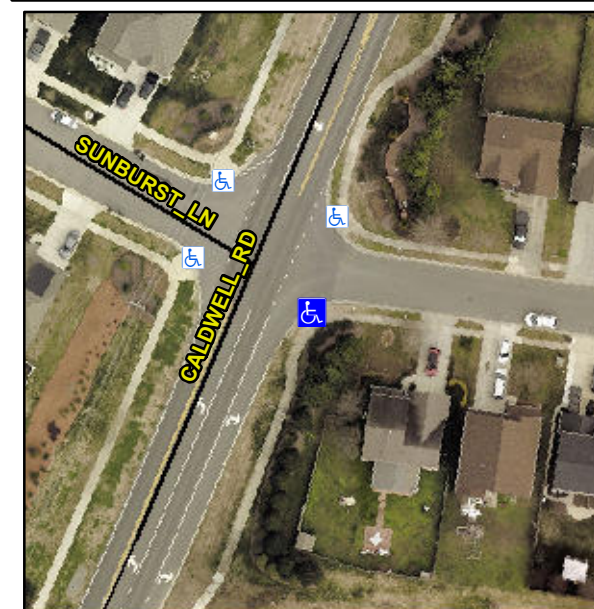
R304.5.1, R304.5.3

Compliance	Description	Data	Compliance	Description	Data
N/A	Ramp Length (in)	50.0	Yes	Ramp Slope (%)	8.1
No	Ramp Width (in)	42.0	No	Ramp XSlope (%)	6.0
N/A	Flare Type LT	N/A	N/A	Flare Type RT	N/A
N/A	Flare Slope LT (%)	N/A	N/A	Flare Slope RT (%)	N/A
N/A	Flare Traversable LT?	N/A	N/A	Flare Traversable RT?	N/A
N/A	Landing Length (in)	N/A	N/A	DWS Provided?	N/A
N/A	Landing Width (in)	N/A	N/A	DWS Contrast?	N/A
N/A	Landing Slope (%)	N/A	N/A	DWS Length (in)	N/A
N/A	Landing X Slope (%)	N/A	N/A	DWS Full Width?	N/A
N/A	Landing Curb? (Y/N)	N/A	N/A	DWS Offset (in)	N/A
N/A	Shared Landing?	N/A			
N/A	Gutter Ponding?	N/A	N/A	Gutter Slope (%)	N/A
N/A	Gutter Lip Ht (in)	N/A	N/A	Gutter X Slope (%)	N/A
N/A	Painted X Walk1?	No	N/A	Painted X Walk2?	No
	X Walk 1 Direction	To NE		X Walk 2 Direction	To NW
N/A	X Walk 1 Width (in)	N/A	N/A	X Walk 2 Width (in)	N/A
	X Walk 1 Slope (%)	4.0		X Walk 2 Slope (%)	6.0
	X Walk 1 X Slope (%)	6.6		X Walk 2 X Slope (%)	0.6

N/A	Ramp inside XWalk1?	N/A	N/A	Ramp inside XWalk2?	N/A
	Road Slope (%)	2.5	N/A	Clear Space?	N/A
	Road X Slope (%)	6.2	N/A	Clear Space to XWalk (in)	N/A
N/A	Any Obstructions?	N/A	N/A	Storm Grate/Utility Hazard?	N/A
	Obstruction Type			Storm Grate/Utility Type	
N/A					N/A
			Yes	Surface Condition? (G/P)	Good

Remove & Replace Curb Ramp With Two New Directional Ramps or Equivalent.
