Access Compliance Report
Public Rights-of-Way
(Curb Ramps)

Intersection ID: 30004	Main Street: DAY_LILLY_LN	Cross Street: MANDY_PLACE_CT	Location:	SE
ADA ID: 23179B095429	Ramp Type: PerpDiag	Initial Pass/Fail: Fail	Overall Compliance: No	Severity Score: 8.75

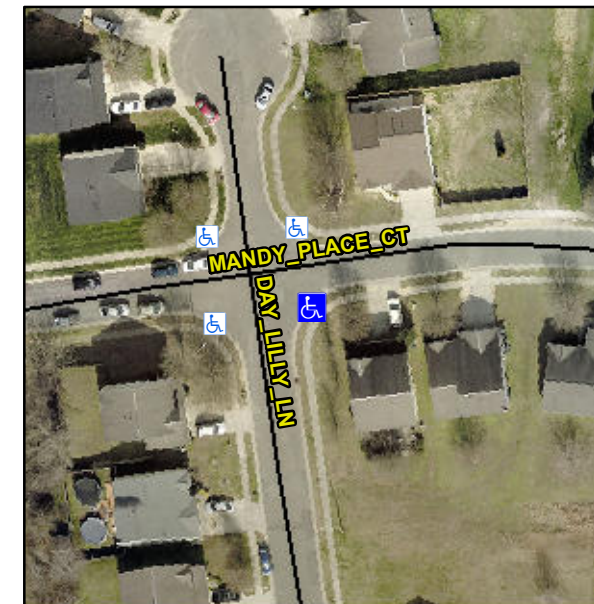
Not Found, R304.5.1

Compliance	Description	Data	Compliance	Description	Data
N/A	Ramp Length (in)	48.0	Yes	Ramp Slope (%)	8.3
No	Ramp Width (in)	44.0	Yes	Ramp XSlope (%)	1.3
N/A	Flare Type LT	N/A	N/A	Flare Type RT	N/A
N/A	Flare Slope LT (%)	N/A	N/A	Flare Slope RT (%)	N/A
N/A	Flare Traversable LT?	N/A	N/A	Flare Traversable RT?	N/A
N/A	Landing Length (in)	N/A	N/A	DWS Provided?	N/A
N/A	Landing Width (in)	N/A	N/A	DWS Contrast?	N/A
N/A	Landing Slope (%)	N/A	N/A	DWS Length (in)	N/A
N/A	Landing X Slope (%)	N/A	N/A	DWS Full Width?	N/A
N/A	Landing Curb? (Y/N)	N/A	N/A	DWS Offset (in)	N/A
N/A	Shared Landing?	N/A			
N/A	Gutter Ponding?	N/A	N/A	Gutter Slope (%)	N/A
N/A	Gutter Lip Ht (in)	N/A	N/A	Gutter X Slope (%)	N/A
N/A	Painted X Walk1?	No	N/A	Painted X Walk2?	No
	X Walk 1 Direction	To N		X Walk 2 Direction	To W
N/A	X Walk 1 Width (in)	N/A	N/A	X Walk 2 Width (in)	N/A
	X Walk 1 Slope (%)	2.6		X Walk 2 Slope (%)	3.5
	X Walk 1 X Slope (%)	2.0		X Walk 2 X Slope (%)	4.1

Remove & Replace Curb Ramp With Two New Directional Ramps or Equivalent.
