# Access Compliance Report
# Public Rights-of-Way
# (Curb Ramps)

| **Intersection ID: 22310** | **Main Street: OAK_CREEK_DR** | **Cross Street: SARDIS_RD** | **Location: S** |
| **ADA ID: 2324F1FB6060** | **Ramp Type: PerpDiag** | **Initial Pass/Fail: Fail** | **Overall Compliance: No** **Severity Score: 33.75** |

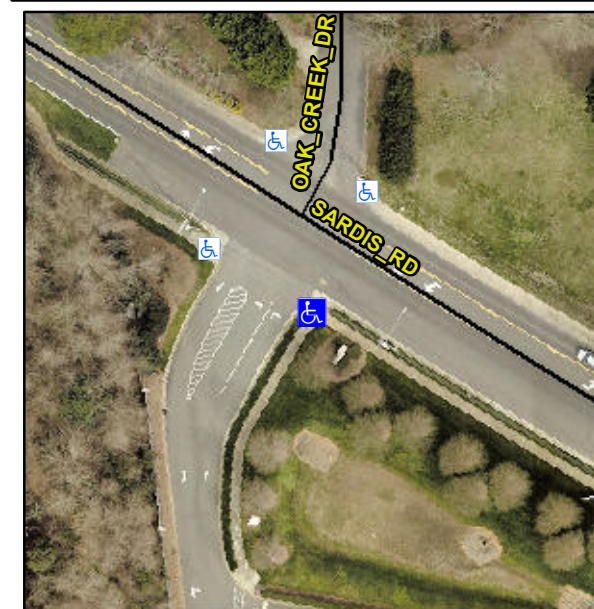
**R304.5.1, R304.2.2, R304.5.3**

| Compliance | Description | Data | Compliance | Description | Data |
|---|---|---|---|---|---|
| N/A | Ramp Length (in) | 59.0 | No | Ramp Slope (%) | 11.1 |
| No | Ramp Width (in) | 41.0 | No | Ramp XSlope (%) | 6.2 |

**Remove & Replace Curb Ramp With Two New Directional Ramps or Equivalent.**
