# Access Compliance Report
Public Rights-of-Way
(Curb Ramps)

Intersection ID: 14505	Main Street: REMOUNT_RD	Cross Street: REMUS_RD	Location:	N
ADA ID: 23399144F4B9	Ramp Type: PerpDiag	Initial Pass/Fail: Fail	Overall Compliance: No	Severity Score: 8.75

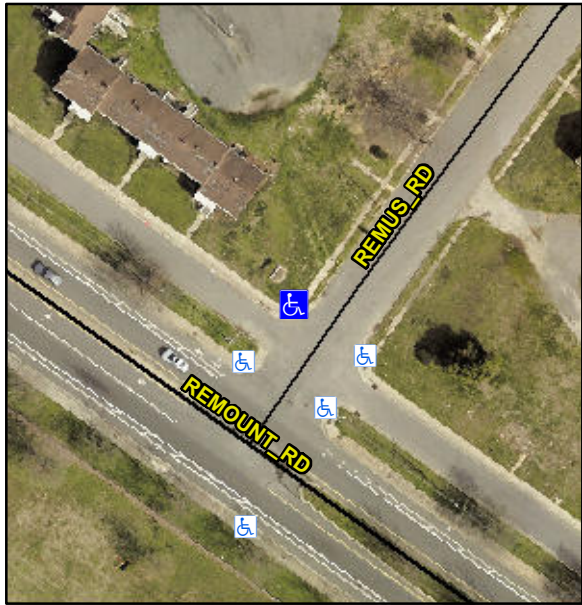
Not Found, R304.5.1

Compliance	Description	Data	Compliance	Description	Data
N/A	Ramp Length (in)	50.0	Yes	Ramp Slope (%)	5.1
No	Ramp Width (in)	42.0	Yes	Ramp XSlope (%)	0.8
N/A	Flare Type LT	N/A	N/A	Flare Type RT	N/A
N/A	Flare Slope LT (%)	N/A	N/A	Flare Slope RT (%)	N/A
N/A	Flare Traversable LT?	N/A	N/A	Flare Traversable RT?	N/A
N/A	Landing Length (in)	N/A	N/A	DWS Provided?	N/A
N/A	Landing Width (in)	N/A	N/A	DWS Contrast?	N/A
N/A	Landing Slope (%)	N/A	N/A	DWS Length (in)	N/A
N/A	Landing X Slope (%)	N/A	N/A	DWS Full Width?	N/A
N/A	Landing Curb? (Y/N)	N/A	N/A	DWS Offset (in)	N/A
N/A	Shared Landing?	N/A			
N/A	Gutter Ponding?	N/A	N/A	Gutter Slope (%)	N/A
N/A	Gutter Lip Ht (in)	N/A	N/A	Gutter X Slope (%)	N/A
N/A	Painted X Walk1?	No	N/A	Painted X Walk2?	No
	X Walk 1 Direction	To SW		X Walk 2 Direction	To SE
N/A	X Walk 1 Width (in)	N/A	N/A	X Walk 2 Width (in)	N/A
	X Walk 1 Slope (%)	3.2		X Walk 2 Slope (%)	1.9
	X Walk 1 X Slope (%)	0.1		X Walk 2 X Slope (%)	2.0

N/A	Ramp inside XWalk1?	N/A	N/A	Ramp inside XWalk2?	N/A
	Road Slope (%)	1.1	N/A	Clear Space?	N/A
	Road X Slope (%)	4.6	N/A	Clear Space to XWalk (in)	N/A
N/A	Any Obstructions?	N/A	N/A	Storm Grate/Utility Hazard?	N/A
	Obstruction Type			Storm Grate/Utility Type	
N/A					N/A
			Yes	Surface Condition? (G/P)	Good

Remove & Replace Curb Ramp With Two New Directional Ramps or Equivalent.
