Access Compliance Report
Public Rights-of-Way
(Curb Ramps)

Intersection ID: 29128	Main Street: HIGHLAND_PARK_DR	Cross Street: HUNTERS_CREEK_CT	Location:	S
ADA ID: 24A245760BD0	Ramp Type: PerpDiag	Initial Pass/Fail: Fail	Overall Compliance: No	Severity Score: 13.75

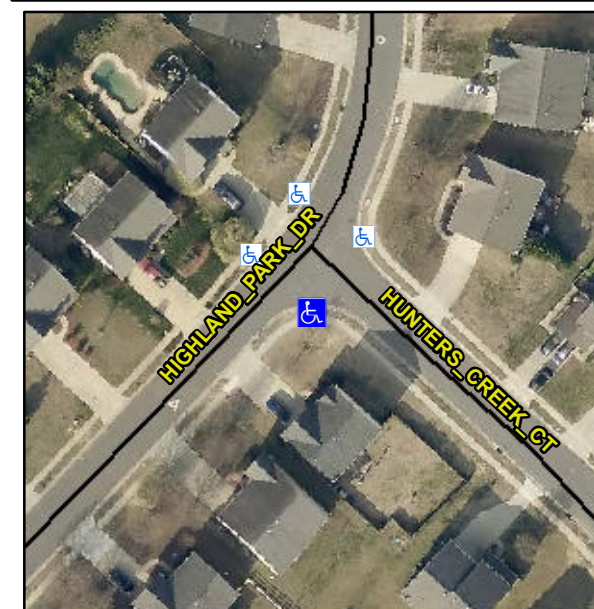
Not Found, R304.2.2, R304.5.3

Compliance	Description	Data	Compliance	Description	Data
N/A	Ramp Length (in)	46.0	No	Ramp Slope (%)	8.5
Yes	Ramp Width (in)	48.0	No	Ramp XSlope (%)	2.5
N/A	Flare Type LT	N/A	N/A	Flare Type RT	N/A
N/A	Flare Slope LT (%)	N/A	N/A	Flare Slope RT (%)	N/A
N/A	Flare Traversable LT?	N/A	N/A	Flare Traversable RT?	N/A
N/A	Landing Length (in)	N/A	N/A	DWS Provided?	N/A
N/A	Landing Width (in)	N/A	N/A	DWS Contrast?	N/A
N/A	Landing Slope (%)	N/A	N/A	DWS Length (in)	N/A
N/A	Landing X Slope (%)	N/A	N/A	DWS Full Width?	N/A
N/A	Landing Curb? (Y/N)	N/A	N/A	DWS Offset (in)	N/A
N/A	Shared Landing?	N/A			
N/A	Gutter Ponding?	N/A	N/A	Gutter Slope (%)	N/A
N/A	Gutter Lip Ht (in)	N/A	N/A	Gutter X Slope (%)	N/A
N/A	Painted X Walk1?	No	N/A	Painted X Walk2?	No
	X Walk 1 Direction	To NE		X Walk 2 Direction	To NW
N/A	X Walk 1 Width (in)	N/A	N/A	X Walk 2 Width (in)	N/A
	X Walk 1 Slope (%)	2.0		X Walk 2 Slope (%)	4.2
	X Walk 1 X Slope (%)	5.6		X Walk 2 X Slope (%)	3.5

N/A	Ramp inside XWalk1?	N/A	N/A	Ramp inside XWalk2?	N/A
	Road Slope (%)	2.9	N/A	Clear Space?	N/A
	Road X Slope (%)	5.3	N/A	Clear Space to XWalk (in)	N/A
N/A	Any Obstructions?	N/A	N/A	Storm Grate/Utility Hazard?	N/A
	Obstruction Type			Storm Grate/Utility Type	
N/A					N/A
			Yes	Surface Condition? (G/P)	Good

Remove & Replace Curb Ramp With Two New Directional Ramps or Equivalent.
