Access Compliance Report
Public Rights-of-Way
(Curb Ramps)

Intersection ID: 28050	Main Street: TENENCIA_CT	Cross Street: WILLOW_ROCK_DR	Location:	S
ADA ID: 2547D377D958	Ramp Type: PerpDiag	Initial Pass/Fail: Fail	Overall Compliance: No	Severity Score: 10

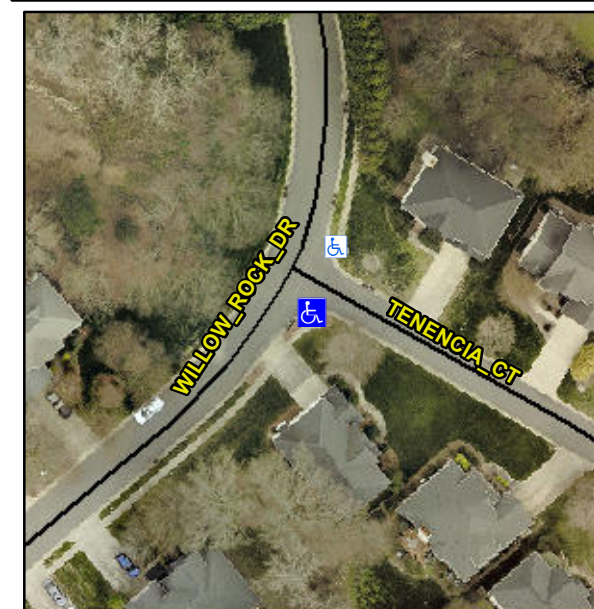
R304.5.1, R304.5.3

Compliance	Description	Data	Compliance	Description	Data
N/A	Ramp Length (in)	53.0	Yes	Ramp Slope (%)	5.5
No	Ramp Width (in)	40.0	No	Ramp XSlope (%)	4.1
N/A	Flare Type LT	N/A	N/A	Flare Type RT	N/A
N/A	Flare Slope LT (%)	N/A	N/A	Flare Slope RT (%)	N/A
N/A	Flare Traversable LT?	N/A	N/A	Flare Traversable RT?	N/A
N/A	Landing Length (in)	N/A	N/A	DWS Provided?	N/A
N/A	Landing Width (in)	N/A	N/A	DWS Contrast?	N/A
N/A	Landing Slope (%)	N/A	N/A	DWS Length (in)	N/A
N/A	Landing X Slope (%)	N/A	N/A	DWS Full Width?	N/A
N/A	Landing Curb? (Y/N)	N/A	N/A	DWS Offset (in)	N/A
N/A	Shared Landing?	N/A			
N/A	Gutter Ponding?	N/A	N/A	Gutter Slope (%)	N/A
N/A	Gutter Lip Ht (in)	N/A	N/A	Gutter X Slope (%)	N/A
N/A	Painted X Walk1?	No	N/A	Painted X Walk2?	No
	X Walk 1 Direction	To NE		X Walk 2 Direction	To NW
N/A	X Walk 1 Width (in)	N/A	N/A	X Walk 2 Width (in)	N/A
	X Walk 1 Slope (%)	0.7		X Walk 2 Slope (%)	0.1
	X Walk 1 X Slope (%)	2.7		X Walk 2 X Slope (%)	0.2

N/A	Ramp inside XWalk1?	N/A	N/A	Ramp inside XWalk2?	N/A
	Road Slope (%)	2.7	N/A	Clear Space?	N/A
	Road X Slope (%)	0.7	N/A	Clear Space to XWalk (in)	N/A
N/A	Any Obstructions?	N/A	N/A	Storm Grate/Utility Hazard?	N/A
	Obstruction Type			Storm Grate/Utility Type	
N/A					N/A
			Yes	Surface Condition? (G/P)	Good

Remove & Replace Curb Ramp With Two New Directional Ramps or Equivalent.
