Access Compliance Report
Public Rights-of-Way
(Curb Ramps)

Intersection ID: 10031975	Main Street: MONROE_RD	Cross Street: N/A	Location:	SW
ADA ID: 255B70EC062D	Ramp Type: Perp	Initial Pass/Fail: Fail	Overall Compliance: No	Severity Score: 21.25

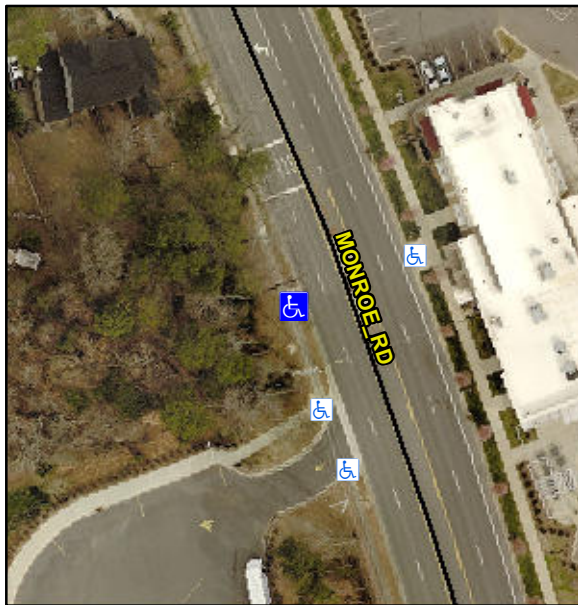
Not Found, R304.5.1, R304.2.2

Compliance	Description	Data	Compliance	Description	Data
N/A	Ramp Length (in)	53.0	No	Ramp Slope (%)	9.8
No	Ramp Width (in)	47.0	Yes	Ramp XSlope (%)	1.2
N/A	Flare Type LT	N/A	N/A	Flare Type RT	N/A
N/A	Flare Slope LT (%)	N/A	N/A	Flare Slope RT (%)	N/A
N/A	Flare Traversable LT?	N/A	N/A	Flare Traversable RT?	N/A
N/A	Landing Length (in)	N/A	N/A	DWS Provided?	N/A
N/A	Landing Width (in)	N/A	N/A	DWS Contrast?	N/A
N/A	Landing Slope (%)	N/A	N/A	DWS Length (in)	N/A
N/A	Landing X Slope (%)	N/A	N/A	DWS Full Width?	N/A
N/A	Landing Curb? (Y/N)	N/A	N/A	DWS Offset (in)	N/A
N/A	Shared Landing?	N/A			
N/A	Gutter Ponding?	N/A	N/A	Gutter Slope (%)	N/A
N/A	Gutter Lip Ht (in)	N/A	N/A	Gutter X Slope (%)	N/A
N/A	Painted X Walk1?	No	N/A	Painted X Walk2?	N/A
	X Walk 1 Direction	To NE		X Walk 2 Direction	N/A
N/A	X Walk 1 Width (in)	N/A	N/A	X Walk 2 Width (in)	N/A
	X Walk 1 Slope (%)	5.5		X Walk 2 Slope (%)	N/A
	X Walk 1 X Slope (%)	1.5		X Walk 2 X Slope (%)	N/A

N/A	Ramp inside XWalk1?	N/A	N/A	Ramp inside XWalk2?	N/A
	Road Slope (%)	N/A	N/A	Clear Space?	N/A
	Road X Slope (%)	N/A	N/A	Clear Space to XWalk (in)	N/A
N/A	Any Obstructions?	N/A	N/A	Storm Grate/Utility Hazard?	N/A
	Obstruction Type			Storm Grate/Utility Type	
N/A					N/A
			Yes	Surface Condition? (G/P)	Good

Remove & Replace Entire Ramp.
