# Access Compliance Report
# Public Rights-of-Way
# (Curb Ramps)

| **Intersection ID:** 26386 | **Main Street:** OVER_STREAM_LN | **Cross Street:** PROVIDENCE_HILLS_DR | **Location:** E |
| **ADA ID:** 256BB2E28807 | **Ramp Type:** BlendTrans2 | **Initial Pass/Fail:** Pass | **Overall Compliance:** No | **Severity Score:** 0 |

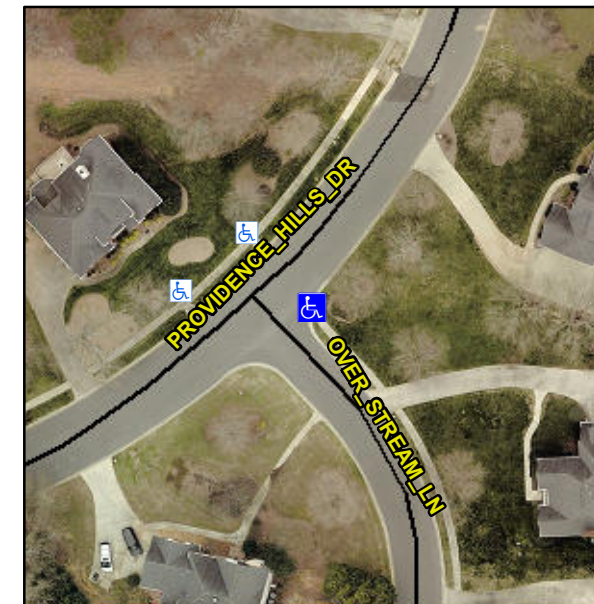
**Not Found, R304.2.3, R305.2**

| Compliance | Description | Data | Compliance | Description | Data |
|---|---|---|---|---|---|
| No | Flare Slope LT (%) | N/A | No | Flare Slope RT (%) | N/A |
| N/A | Landing Curb? (Y/N) | No | No | DWS Offset (in) | 4.0 |
| | | | No | Curb Slope (%) | 8.9 |

**Remove & Replace Curb Ramp With Two New Directional Ramps or Equivalent.**
