# Access Compliance Report
# Public Rights-of-Way
# (Curb Ramps)

| Intersection ID: 14978 | Main Street: COLONNADE_DR | Cross Street: MONROE_RD | Location: | NW |
| ADA ID: 25CE41BB3B5D | Ramp Type: PerpDiag | Initial Pass/Fail: Fail | Overall Compliance: No | Severity Score: 33.75 |

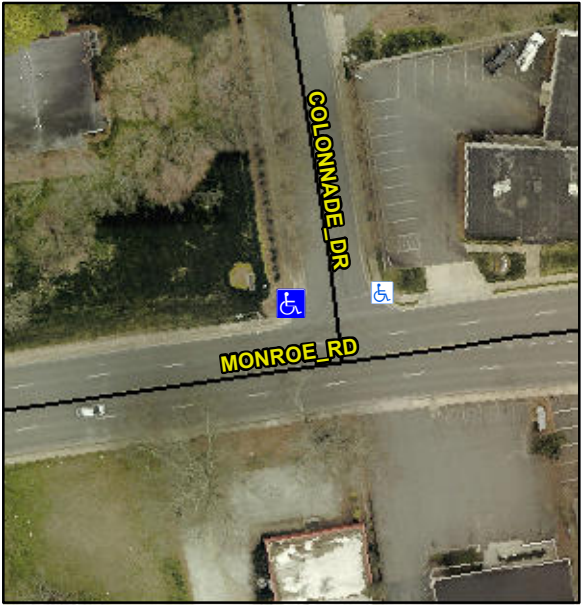
**Not Found, R304.5.1, R304.2.2, R304.5.3**

| Compliance | Description | Data | Compliance | Description | Data |
|---|---|---|---|---|---|
| N/A | Ramp Length (in) | 58.5 | No | Ramp Slope (%) | 8.9 |
| No | Ramp Width (in) | 39.5 | No | Ramp XSlope (%) | 5.8 |

**Remove & Replace Curb Ramp With Two New Directional Ramps or Equivalent.**
