Access Compliance Report
Public Rights-of-Way
(Curb Ramps)

Intersection ID: 8116 | **Main Street:** GOSSETT_AV | **Cross Street:** S_HOSKINS_RD | **Location:** E

ADA ID: 25DF5BD241F8 | **Ramp Type:** PerpDiag | **Initial Pass/Fail:** Fail | **Overall Compliance:** No | **Severity Score:** 8.75

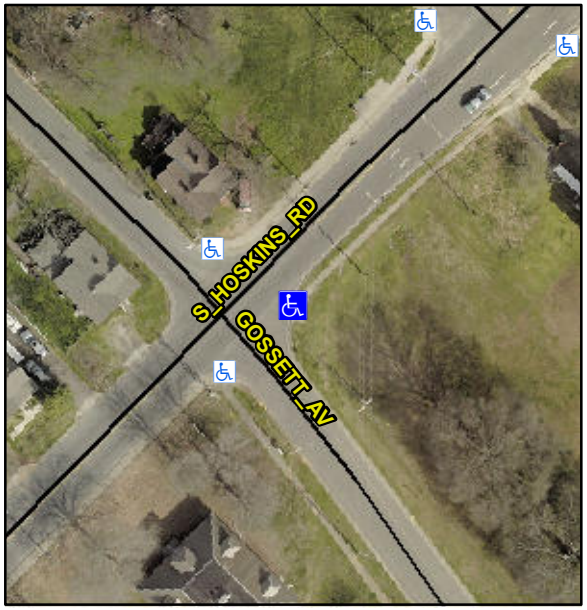
Not Found, R304.5.1

Remove & Replace Curb Ramp With Two New Directional Ramps or Equivalent.
