Access Compliance Report
Public Rights-of-Way
(Curb Ramps)

Intersection ID: N/A | **Main Street:** MONROE_RD | **Cross Street:** RENARD_RIDGE_RD | **Location:** NE

ADA ID: 26B5BFFE7826 | **Ramp Type:** ParaDiag | **Initial Pass/Fail:** Fail | **Overall Compliance:** No | **Severity Score:** 12.5

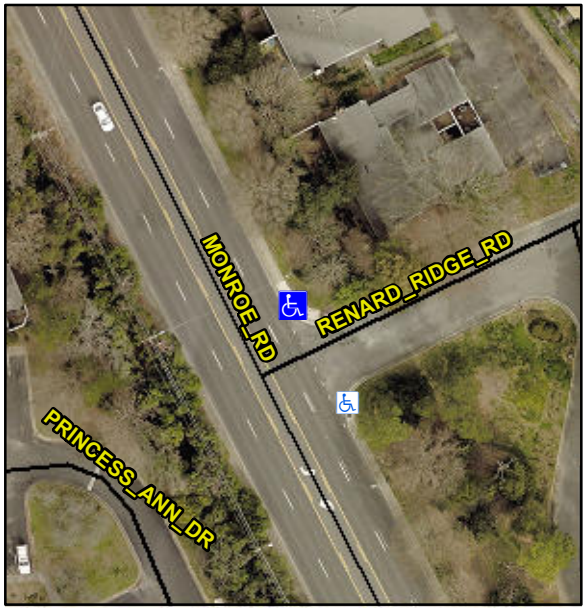
RT RP < 5%

R304.3.2

Remove & Replace Curb Ramp With Two New Directional Ramps or Equivalent.
