Access Compliance Report
Public Rights-of-Way
(Curb Ramps)

Intersection ID: 44780	Main Street: SESSIONS_ST	Cross Street: SILVER_CRESCENT_DR	Location:	NW
ADA ID: 28AC0A1943EF	Ramp Type: PerpDiag	Initial Pass/Fail: Fail	Overall Compliance: No	Severity Score: 12.5

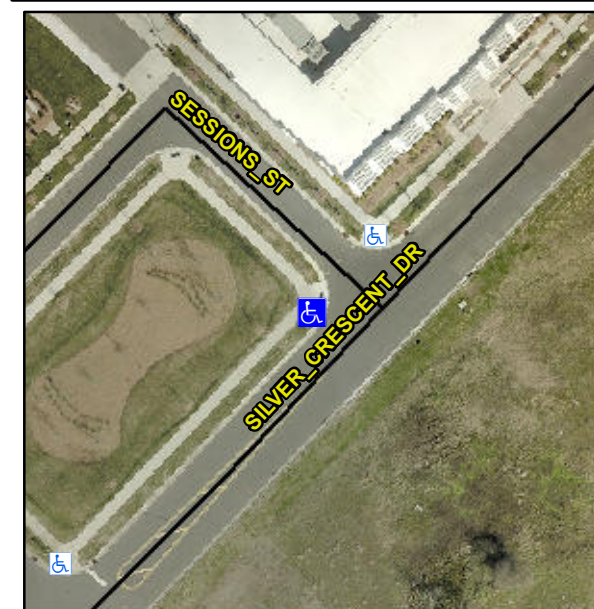
Compliance	Description	Data	Compliance	Description	Data
N/A	Ramp Length (in)	89.0	Yes	Ramp Slope (%)	6.5
Yes	Ramp Width (in)	60.0	No	Ramp XSlope (%)	5.2
N/A	Flare Type LT	N/A	N/A	Flare Type RT	N/A
N/A	Flare Slope LT (%)	N/A	N/A	Flare Slope RT (%)	N/A
N/A	Flare Traversable LT?	N/A	N/A	Flare Traversable RT?	N/A
N/A	Landing Length (in)	N/A	N/A	DWS Provided?	N/A
N/A	Landing Width (in)	N/A	N/A	DWS Contrast?	N/A
N/A	Landing Slope (%)	N/A	N/A	DWS Length (in)	N/A
N/A	Landing X Slope (%)	N/A	N/A	DWS Full Width?	N/A
N/A	Landing Curb? (Y/N)	N/A	N/A	DWS Offset (in)	N/A
N/A	Shared Landing?	N/A			
N/A	Gutter Ponding?	N/A	N/A	Gutter Slope (%)	N/A
N/A	Gutter Lip Ht (in)	N/A	N/A	Gutter X Slope (%)	N/A
N/A	Painted X Walk1?	No	N/A	Painted X Walk2?	No
	X Walk 1 Direction	To SE		X Walk 2 Direction	To NE
N/A	X Walk 1 Width (in)	N/A	N/A	X Walk 2 Width (in)	N/A
	X Walk 1 Slope (%)	0.7		X Walk 2 Slope (%)	2.2
	X Walk 1 X Slope (%)	1.6		X Walk 2 X Slope (%)	1.3

N/A	Ramp inside XWalk1?	N/A	N/A	Ramp inside XWalk2?	N/A
	Road Slope (%)	2.7	N/A	Clear Space?	N/A
	Road X Slope (%)	2.4	N/A	Clear Space to XWalk (in)	N/A
N/A	Any Obstructions?	N/A	N/A	Storm Grate/Utility Hazard?	N/A
	Obstruction Type			Storm Grate/Utility Type	
N/A					N/A
			Yes	Surface Condition? (G/P)	Good

Remove & Replace Curb Ramp With Two New Directional Ramps or Equivalent.
