# Access Compliance Report
Public Rights-of-Way
(Curb Ramps)

Intersection ID: 10041631	Main Street: WHITEHALL_PARK_DR	Cross Street: N/A	Location:	NW
ADA ID: 28BDC211EA0C	Ramp Type: PerpDiag	Initial Pass/Fail: Fail	Overall Compliance: No	Severity Score: 21.25

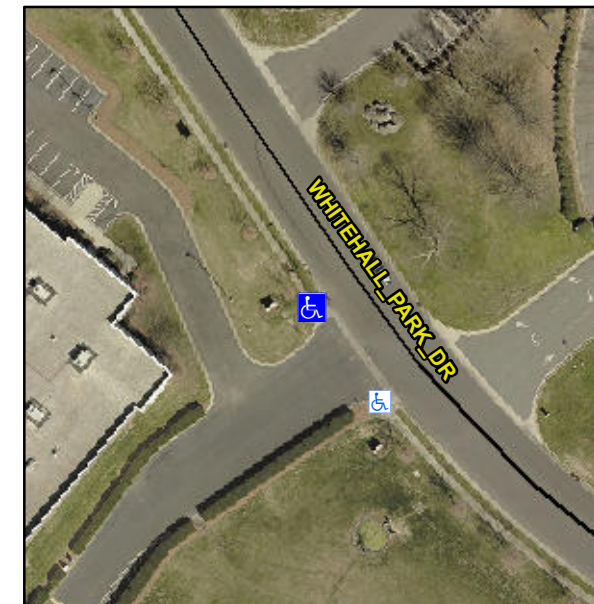
Not Found, R304.5.1, R304.2.2

Compliance	Description	Data	Compliance	Description	Data
N/A	Ramp Length (in)	95.0	No	Ramp Slope (%)	8.8
No	Ramp Width (in)	45.0	Yes	Ramp XSlope (%)	0.8
N/A	Flare Type LT	N/A	N/A	Flare Type RT	N/A
N/A	Flare Slope LT (%)	N/A	N/A	Flare Slope RT (%)	N/A
N/A	Flare Traversable LT?	N/A	N/A	Flare Traversable RT?	N/A
N/A	Landing Length (in)	N/A	N/A	DWS Provided?	N/A
N/A	Landing Width (in)	N/A	N/A	DWS Contrast?	N/A
N/A	Landing Slope (%)	N/A	N/A	DWS Length (in)	N/A
N/A	Landing X Slope (%)	N/A	N/A	DWS Full Width?	N/A
N/A	Landing Curb? (Y/N)	N/A	N/A	DWS Offset (in)	N/A
N/A	Shared Landing?	N/A			
N/A	Gutter Ponding?	N/A	N/A	Gutter Slope (%)	N/A
N/A	Gutter Lip Ht (in)	N/A	N/A	Gutter X Slope (%)	N/A
N/A	Painted X Walk1?	No	N/A	Painted X Walk2?	No
	X Walk 1 Direction	To SE		X Walk 2 Direction	To NE
N/A	X Walk 1 Width (in)	N/A	N/A	X Walk 2 Width (in)	N/A
	X Walk 1 Slope (%)	0.1		X Walk 2 Slope (%)	1.8
	X Walk 1 X Slope (%)	5.5		X Walk 2 X Slope (%)	1.3

Remove & Replace Curb Ramp With Two New Directional Ramps or Equivalent.
