Access Compliance Report

# Public Rights-of-Way
(Curb Ramps)

Intersection ID: 23662	Main Street: CARMEL_RD	Cross Street: RED_OAK_LN	Location:	NE
ADA ID: 2924BAFB0EA1	Ramp Type: PerpDiag	Initial Pass/Fail: Fail	Overall Compliance: No	Severity Score: 12.5

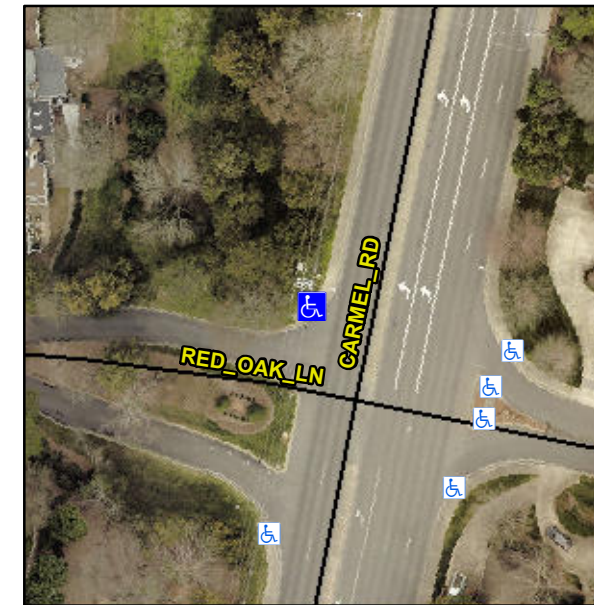
Not Found, R304.5.3

Compliance	Description	Data	Compliance	Description	Data
N/A	Ramp Length (in)	59.0	Yes	Ramp Slope (%)	7.0
Yes	Ramp Width (in)	59.0	No	Ramp XSlope (%)	6.6
N/A	Flare Type LT	N/A	N/A	Flare Type RT	N/A
N/A	Flare Slope LT (%)	N/A	N/A	Flare Slope RT (%)	N/A
N/A	Flare Traversable LT?	N/A	N/A	Flare Traversable RT?	N/A
N/A	Landing Length (in)	N/A	N/A	DWS Provided?	N/A
N/A	Landing Width (in)	N/A	N/A	DWS Contrast?	N/A
N/A	Landing Slope (%)	N/A	N/A	DWS Length (in)	N/A
N/A	Landing X Slope (%)	N/A	N/A	DWS Full Width?	N/A
N/A	Landing Curb? (Y/N)	N/A	N/A	DWS Offset (in)	N/A
N/A	Shared Landing?	N/A			
N/A	Gutter Ponding?	N/A	N/A	Gutter Slope (%)	N/A
N/A	Gutter Lip Ht (in)	N/A	N/A	Gutter X Slope (%)	N/A
N/A	Painted X Walk1?	No	N/A	Painted X Walk2?	No
	X Walk 1 Direction	To S		X Walk 2 Direction	To E
N/A	X Walk 1 Width (in)	N/A	N/A	X Walk 2 Width (in)	N/A
	X Walk 1 Slope (%)	3.8		X Walk 2 Slope (%)	9.2
	X Walk 1 X Slope (%)	5.9		X Walk 2 X Slope (%)	1.7

N/A	Ramp inside XWalk1?	N/A	N/A	Ramp inside XWalk2?	N/A
	Road Slope (%)	4.3	N/A	Clear Space?	N/A
	Road X Slope (%)	5.7	N/A	Clear Space to XWalk (in)	N/A
N/A	Any Obstructions?	N/A	N/A	Storm Grate/Utility Hazard?	N/A
	Obstruction Type			Storm Grate/Utility Type	
N/A					N/A
			Yes	Surface Condition? (G/P)	Good

Remove & Replace Curb Ramp With Two New Directional Ramps or Equivalent.
