Access Compliance Report
Public Rights-of-Way
(Curb Ramps)

Intersection ID: 8756 **Main Street:** BRADFORD_DR **Cross Street:** ROWAN_ST **Location:** SE

ADA ID: 292FD2CA4DA5 **Ramp Type:** Perp **Initial Pass/Fail:** Fail **Overall Compliance:** No **Severity Score:** 12.5

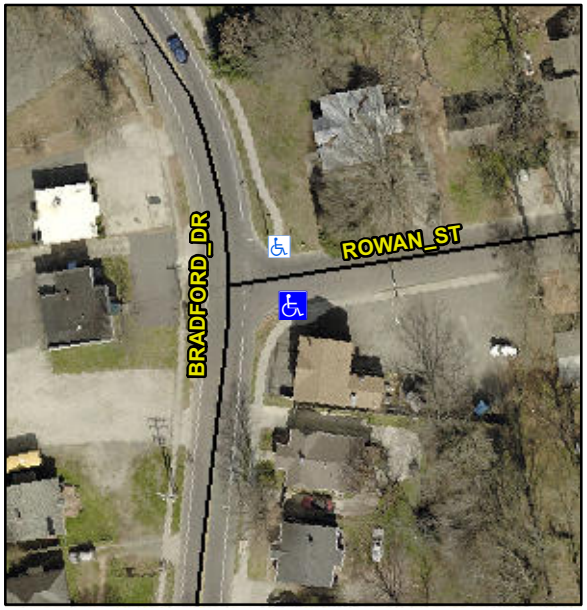
R304.2.2

Compliance	Description	Data	Compliance	Description	Data
N/A	Ramp Length (in)	66.0	No	Ramp Slope (%)	9.0
Yes	Ramp Width (in)	48.0	Yes	Ramp XSlope (%)	0.3
N/A	Flare Type LT	N/A	N/A	Flare Type RT	N/A
N/A	Flare Slope LT (%)	N/A	N/A	Flare Slope RT (%)	N/A
N/A	Flare Traversable LT?	N/A	N/A	Flare Traversable RT?	N/A
N/A	Landing Length (in)	N/A	N/A	DWS Provided?	N/A
N/A	Landing Width (in)	N/A	N/A	DWS Contrast?	N/A
N/A	Landing Slope (%)	N/A	N/A	DWS Length (in)	N/A
N/A	Landing X Slope (%)	N/A	N/A	DWS Full Width?	N/A
N/A	Landing Curb? (Y/N)	N/A	N/A	DWS Offset (in)	N/A
N/A	Shared Landing?	N/A			
N/A	Gutter Ponding?	N/A	N/A	Gutter Slope (%)	N/A
N/A	Gutter Lip Ht (in)	N/A	N/A	Gutter X Slope (%)	N/A
N/A	Painted X Walk1?	No	N/A	Painted X Walk2?	N/A
	X Walk 1 Direction	To N		X Walk 2 Direction	N/A
N/A	X Walk 1 Width (in)	N/A	N/A	X Walk 2 Width (in)	N/A
	X Walk 1 Slope (%)	2.6		X Walk 2 Slope (%)	N/A
	X Walk 1 X Slope (%)	0.9		X Walk 2 X Slope (%)	N/A

Remove & Replace Entire Ramp.
