Access Compliance Report
Public Rights-of-Way
(Curb Ramps)

Intersection ID: 3030	**Main Street:** AMBER_GLEN_DR	**Cross Street:** JASPAR_CREST_LN	**Location:** N
ADA ID: 29592C019650	**Ramp Type:** Perp	**Initial Pass/Fail:** Fail	**Overall Compliance:** No	**Severity Score:** 8.75

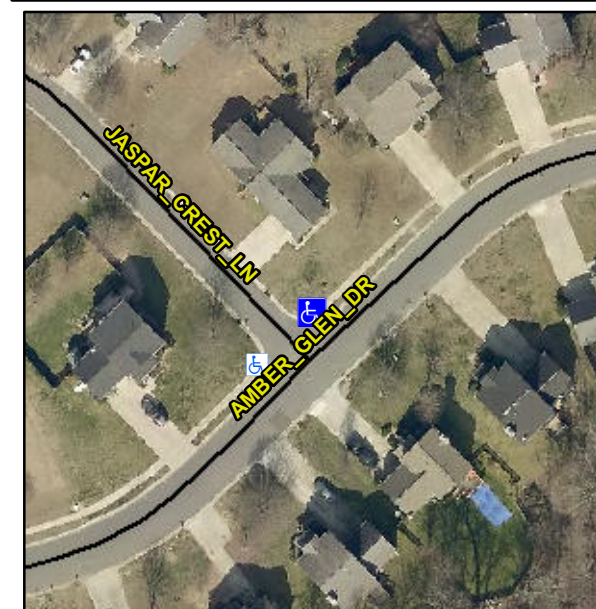
Not Found, R304.5.1

Compliance	Description	Data	Compliance	Description	Data
N/A	Ramp Length (in)	44.0	Yes	Ramp Slope (%)	5.7
No	Ramp Width (in)	46.0	Yes	Ramp XSlope (%)	0.0
N/A	Flare Type LT	N/A	N/A	Flare Type RT	N/A
N/A	Flare Slope LT (%)	N/A	N/A	Flare Slope RT (%)	N/A
N/A	Flare Traversable LT?	N/A	N/A	Flare Traversable RT?	N/A
N/A	Landing Length (in)	N/A	N/A	DWS Provided?	N/A
N/A	Landing Width (in)	N/A	N/A	DWS Contrast?	N/A
N/A	Landing Slope (%)	N/A	N/A	DWS Length (in)	N/A
N/A	Landing X Slope (%)	N/A	N/A	DWS Full Width?	N/A
N/A	Landing Curb? (Y/N)	N/A	N/A	DWS Offset (in)	N/A
N/A	Shared Landing?	N/A			
N/A	Gutter Ponding?	N/A	N/A	Gutter Slope (%)	N/A
N/A	Gutter Lip Ht (in)	N/A	N/A	Gutter X Slope (%)	N/A
N/A	Painted X Walk1?	No	N/A	Painted X Walk2?	N/A
	X Walk 1 Direction	To SW		X Walk 2 Direction	N/A
N/A	X Walk 1 Width (in)	N/A	N/A	X Walk 2 Width (in)	N/A
	X Walk 1 Slope (%)	1.4		X Walk 2 Slope (%)	N/A
	X Walk 1 X Slope (%)	1.7		X Walk 2 X Slope (%)	N/A

N/A	Ramp inside XWalk1?	N/A	N/A	Ramp inside XWalk2?	N/A
	Road Slope (%)	N/A	N/A	Clear Space?	N/A
	Road X Slope (%)	N/A	N/A	Clear Space to XWalk (in)	N/A
N/A	Any Obstructions?	N/A	N/A	Storm Grate/Utility Hazard?	N/A
	Obstruction Type			Storm Grate/Utility Type	
N/A					N/A
			Yes	Surface Condition? (G/P)	Good

Remove & Replace Entire Ramp.
