Access Compliance Report
Public Rights-of-Way
(Curb Ramps)

Intersection ID: 48771	Main Street: LUMBER_LN	Cross Street: TURNING_WHEEL_DR	Location:	NE
ADA ID: 29AC4B82A5CA	Ramp Type: Perp	Initial Pass/Fail: Fail	Overall Compliance: No	Severity Score: 8.75

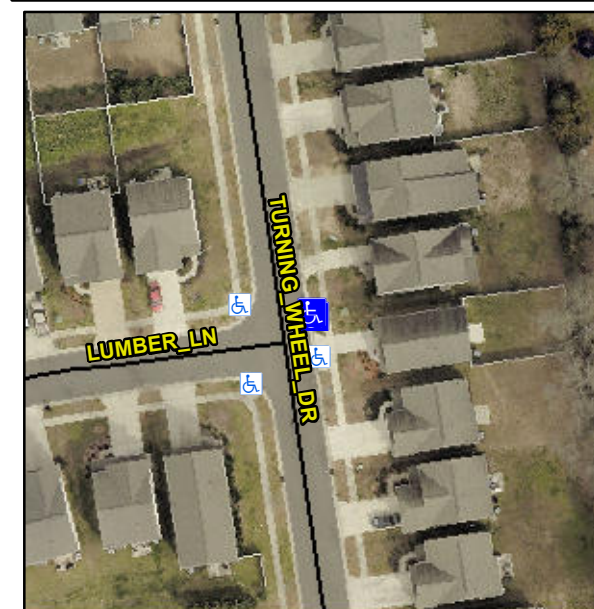
Not Found, R304.5.1

Compliance	Description	Data	Compliance	Description	Data
N/A	Ramp Length (in)	71.0	Yes	Ramp Slope (%)	7.7
No	Ramp Width (in)	47.0	Yes	Ramp XSlope (%)	1.3
N/A	Flare Type LT	N/A	N/A	Flare Type RT	N/A
N/A	Flare Slope LT (%)	N/A	N/A	Flare Slope RT (%)	N/A
N/A	Flare Traversable LT?	N/A	N/A	Flare Traversable RT?	N/A
N/A	Landing Length (in)	N/A	N/A	DWS Provided?	N/A
N/A	Landing Width (in)	N/A	N/A	DWS Contrast?	N/A
N/A	Landing Slope (%)	N/A	N/A	DWS Length (in)	N/A
N/A	Landing X Slope (%)	N/A	N/A	DWS Full Width?	N/A
N/A	Landing Curb? (Y/N)	N/A	N/A	DWS Offset (in)	N/A
N/A	Shared Landing?	N/A			
N/A	Gutter Ponding?	N/A	N/A	Gutter Slope (%)	N/A
N/A	Gutter Lip Ht (in)	N/A	N/A	Gutter X Slope (%)	N/A
N/A	Painted X Walk1?	No	N/A	Painted X Walk2?	N/A
	X Walk 1 Direction	To W		X Walk 2 Direction	N/A
N/A	X Walk 1 Width (in)	N/A	N/A	X Walk 2 Width (in)	N/A
	X Walk 1 Slope (%)	4.3		X Walk 2 Slope (%)	N/A
	X Walk 1 X Slope (%)	1.8		X Walk 2 X Slope (%)	N/A

Remove & Replace Entire Ramp.
