# Access Compliance Report
Public Rights-of-Way
(Curb Ramps)

Intersection ID: 18538	Main Street: SENECA_PL	Cross Street: SOUTH_BV	Location:	NE
ADA ID: 2A790D50BD31	Ramp Type: Perp	Initial Pass/Fail: Fail	Overall Compliance: No	Severity Score: 21.25

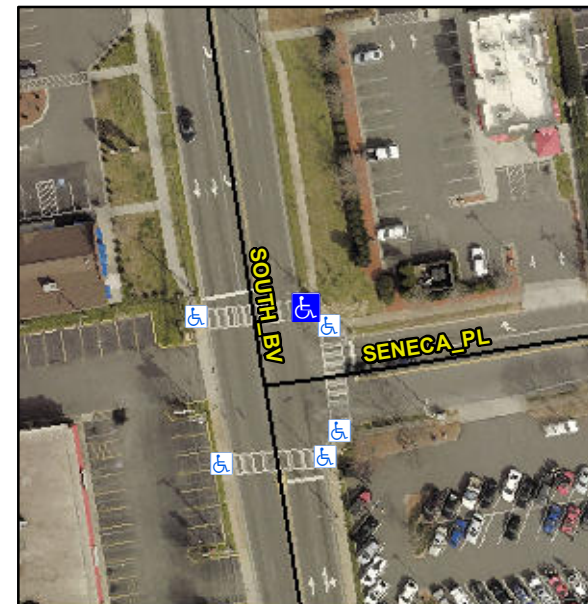
Not Found, R304.5.1, R304.2.2

Compliance	Description	Data	Compliance	Description	Data
N/A	Ramp Length (in)	47.0	No	Ramp Slope (%)	8.5
No	Ramp Width (in)	47.0	Yes	Ramp XSlope (%)	0.3
N/A	Flare Type LT	N/A	N/A	Flare Type RT	N/A
N/A	Flare Slope LT (%)	N/A	N/A	Flare Slope RT (%)	N/A
N/A	Flare Traversable LT?	N/A	N/A	Flare Traversable RT?	N/A
N/A	Landing Length (in)	N/A	N/A	DWS Provided?	N/A
N/A	Landing Width (in)	N/A	N/A	DWS Contrast?	N/A
N/A	Landing Slope (%)	N/A	N/A	DWS Length (in)	N/A
N/A	Landing X Slope (%)	N/A	N/A	DWS Full Width?	N/A
N/A	Landing Curb? (Y/N)	N/A	N/A	DWS Offset (in)	N/A
N/A	Shared Landing?	N/A			
N/A	Gutter Ponding?	N/A	N/A	Gutter Slope (%)	N/A
N/A	Gutter Lip Ht (in)	N/A	N/A	Gutter X Slope (%)	N/A
N/A	Painted X Walk1?	Yes	N/A	Painted X Walk2?	N/A
	X Walk 1 Direction	To W		X Walk 2 Direction	N/A
N/A	X Walk 1 Width (in)	112.0	N/A	X Walk 2 Width (in)	N/A
	X Walk 1 Slope (%)	3.9		X Walk 2 Slope (%)	N/A
	X Walk 1 X Slope (%)	1.4		X Walk 2 X Slope (%)	N/A

Remove & Replace Entire Ramp.
