# Access Compliance Report
Public Rights-of-Way
(Curb Ramps)

Intersection ID: 17531	Main Street: HILLSIDE_AV	Cross Street: WESTFIELD_RD	Location:	SW
ADA ID: 2C812E8F8B11	Ramp Type: PerpDiag	Initial Pass/Fail: Fail	Overall Compliance: No	Severity Score: 8.75

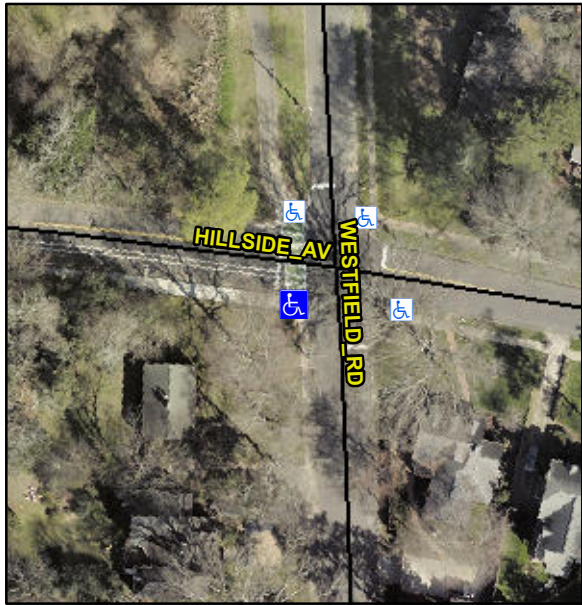
Compliance	Description	Data	Compliance	Description	Data
N/A	Ramp Length (in)	51.0	Yes	Ramp Slope (%)	7.7
No	Ramp Width (in)	47.0	Yes	Ramp XSlope (%)	0.8
N/A	Flare Type LT	N/A	N/A	Flare Type RT	N/A
N/A	Flare Slope LT (%)	N/A	N/A	Flare Slope RT (%)	N/A
N/A	Flare Traversable LT?	N/A	N/A	Flare Traversable RT?	N/A
N/A	Landing Length (in)	N/A	N/A	DWS Provided?	N/A
N/A	Landing Width (in)	N/A	N/A	DWS Contrast?	N/A
N/A	Landing Slope (%)	N/A	N/A	DWS Length (in)	N/A
N/A	Landing X Slope (%)	N/A	N/A	DWS Full Width?	N/A
N/A	Landing Curb? (Y/N)	N/A	N/A	DWS Offset (in)	N/A
N/A	Shared Landing?	N/A			
N/A	Gutter Ponding?	N/A	N/A	Gutter Slope (%)	N/A
N/A	Gutter Lip Ht (in)	N/A	N/A	Gutter X Slope (%)	N/A
N/A	Painted X Walk1?	No	N/A	Painted X Walk2?	No
	X Walk 1 Direction	To E		X Walk 2 Direction	To N
N/A	X Walk 1 Width (in)	N/A	N/A	X Walk 2 Width (in)	N/A
	X Walk 1 Slope (%)	1.4		X Walk 2 Slope (%)	3.5
	X Walk 1 X Slope (%)	5.3		X Walk 2 X Slope (%)	1.7

N/A	Ramp inside XWalk1?	N/A	N/A	Ramp inside XWalk2?	N/A
	Road Slope (%)	2.0	N/A	Clear Space?	N/A
	Road X Slope (%)	5.9	N/A	Clear Space to XWalk (in)	N/A
N/A	Any Obstructions?	N/A	N/A	Storm Grate/Utility Hazard?	N/A
	Obstruction Type			Storm Grate/Utility Type	
N/A					N/A
			Yes	Surface Condition? (G/P)	Good

Remove & Replace Curb Ramp With Two New Directional Ramps or Equivalent.
